Demining Programme Office in the Falkland Islands – Technical Support 2010

April 2010

TECHNICAL SUPPORT TO THE FALKLANDS DEMINING PROGRAMME

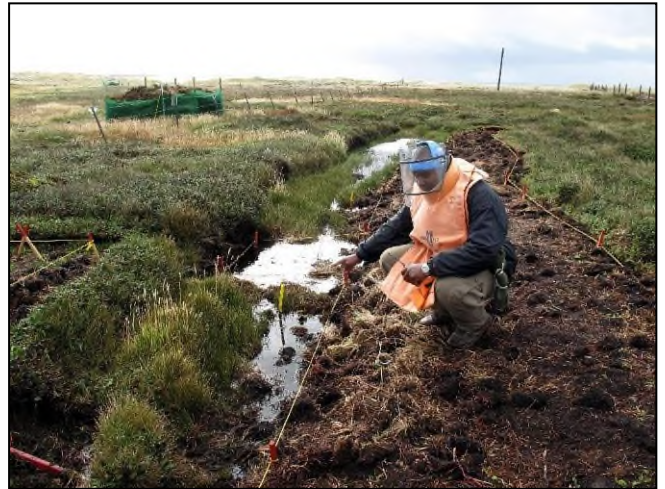
A wet ditch containing a number of mines

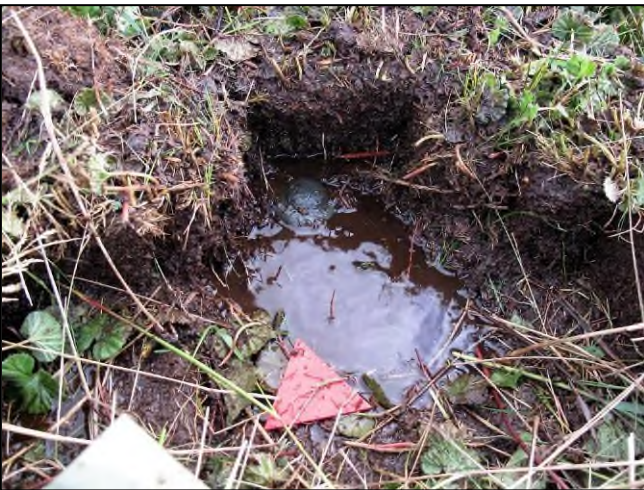
An SB-33 AP mine under water

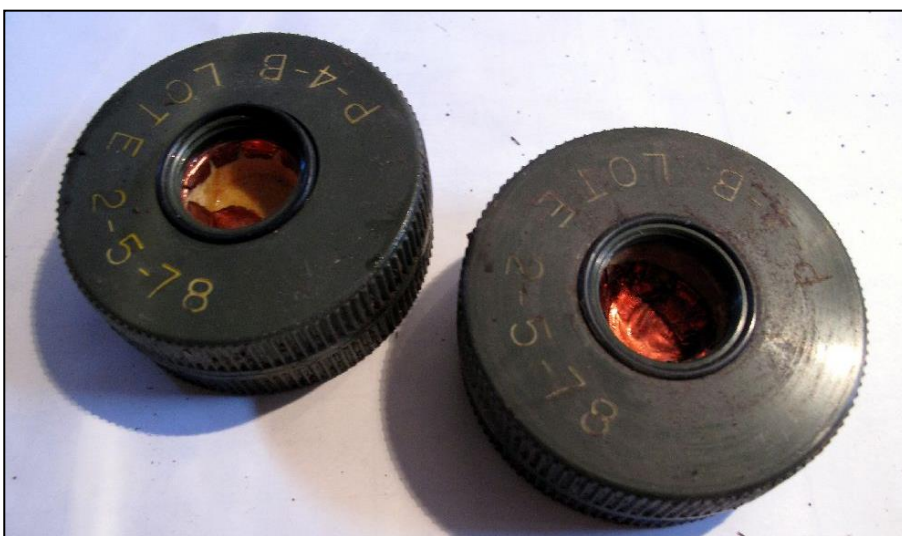
Figure 3

Throughout the course of the clearance operation, all but one of the P4B mines examined had the red lacquered lead foil present in fuze well. As the fuze assembly is fitted, this foil ruptures in unpredictable patterns (Figure 3). The shape of the ruptured foil is known to affect the return on short-wave radar and may also affect the signature with some metal detectors.

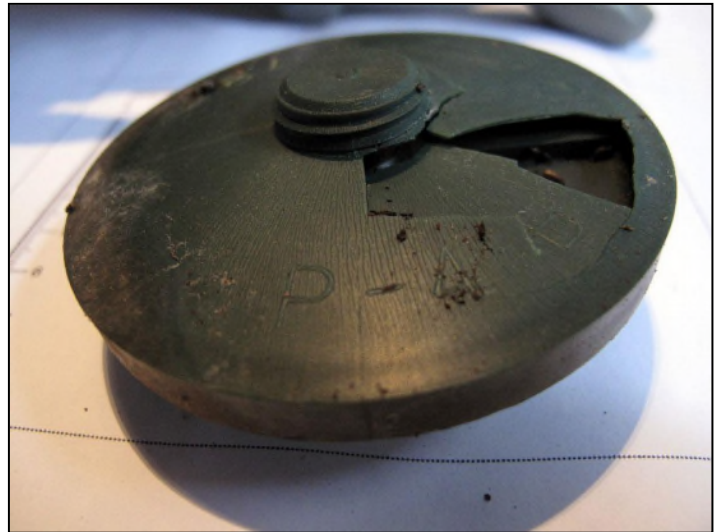
The P4B pressure plate shown in Figures 4 and 5 shows the type of long-term deterioration expected in ABS plastic. Increasing brittleness has caused fine cracks where the plastic is under stress; this has led to eventual failure, permitting the ingress of water. In most samples examined, cracking was not immediately visible; however, it is evident that the plastic is becoming more brittle and that all casings would eventually reach this stage. Previous studies have shown that such deterioration accelerates, since the effects (such as increasing the exposed surface area) make the material even more vulnerable to further degradation. Extensive tests would be required in order to assess the rate of degradation.

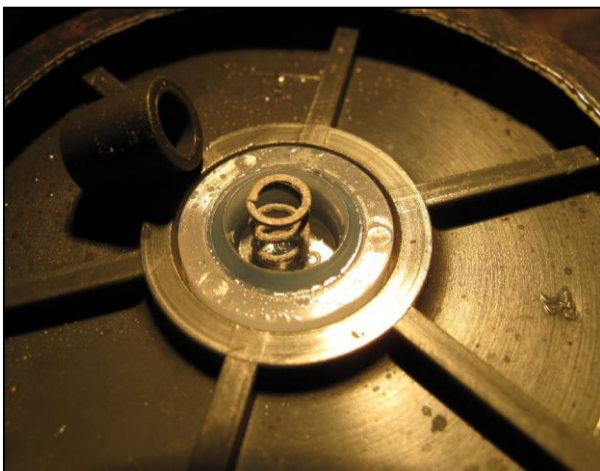
Figure 6

Even where water had penetrated the fuze assembly, the firing spring (Figure 6) was in remarkably good condition and remained fully functional. This was surprising, although, had the mines been nearer the coast, salt-water would probably have caused more extensive rusting. This would further degrade the detection signal from the small metallic mass.

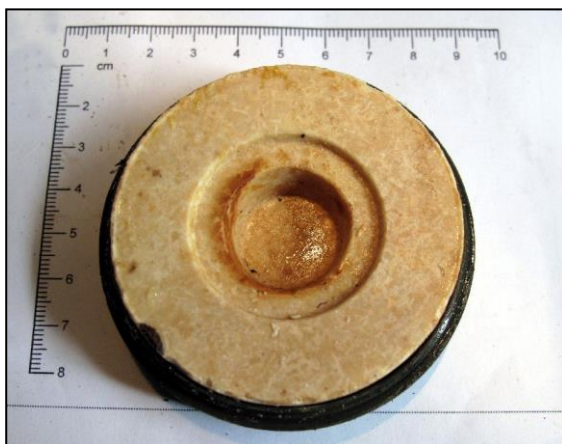
Figure 10

As expected, the pressed TNT charges (Figure 10) were in good condition, despite many being wet. TNT is relatively stable, especially when protected from sunlight. This High Explosive (HE) content is likely to remain functional for the foreseeable future.

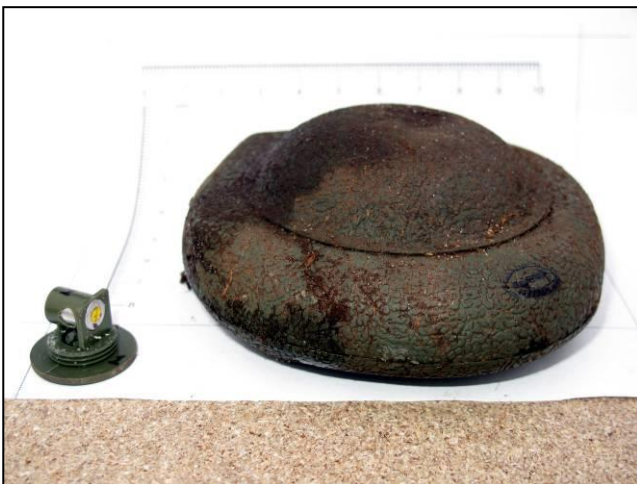
Seventeen SB-33 mines were recovered from a mixture of dry and wet sites (Figures 1 and 2). None of the SB-33 mines examined showed signs of significant external degradation, other than a notable increase in the profile of the rubber pressure plate; this is clear from Figures 3 and 4.

Figure 3: An SB-33 recovered from the Falklands; note the domed profile of the pressure plate

Expansion of the rubber appears to be due to the material softening when wet, although it continued to be waterproof. As the rubber dried, the height of the dome reduced noticeably, but not to the original profile.

Examination of the casing and pressure plate showed that the upper sections of all of the mines had remained watertight. Where water had penetrated, this appeared to be because the detonator plug (to the left in Figure 3) had not been tightened sufficiently.

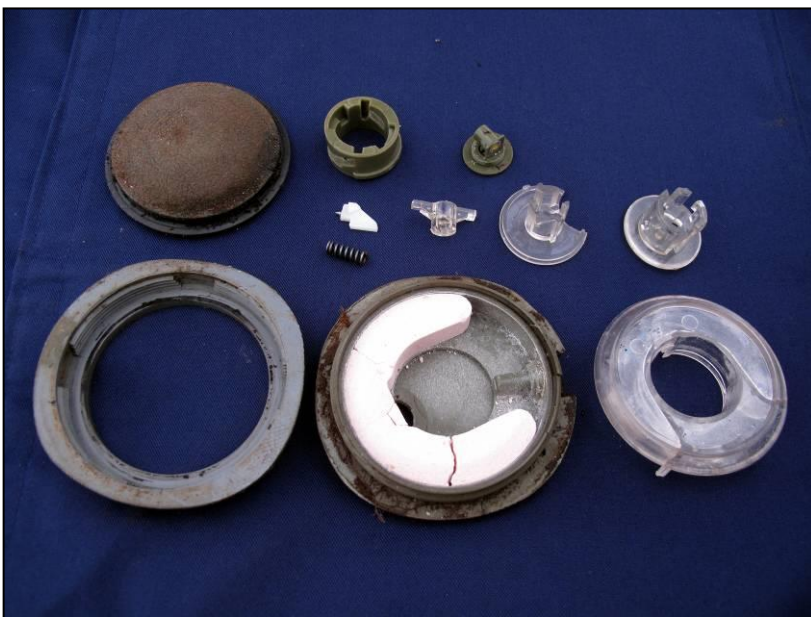
Figure 7 shows a recovered SB-33 disassembled. Most of the clear plastic internal fuze components are made from polycarbonate, and are therefore extremely strong.

None of the internal components showed any mechanical damage. The main charge (RDX/HMX) was often cracked, but this would not affect performance.

Although the mines were generally well sealed, several were damp inside. In many cases this had caused very minor rusting of the striker spring (which is made from spring steel 'piano wire'). This superficial corrosion would have no effect on the performance of the mechanism, nor would it effect the detectability of the mine.

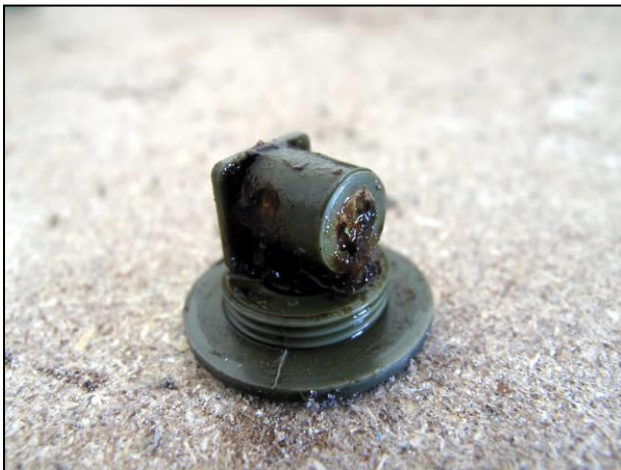
Figure 10: Some detonator capsules did show significant signs of degradation

There was obvious degradation where detonator capsules had been exposed to water for prolonged periods. It is likely that this had breached the seals of the capsule, particularly the thin yellow membrane covering the stab receptor. This is significant because the stab-receptive composition is likely to be affected by water, which may cause the mine to malfunction.

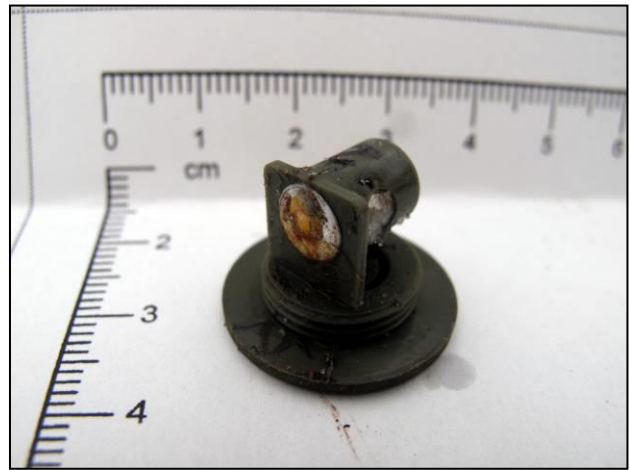
Figure 11: The yellow seal on the stab receptor appears to have been breached

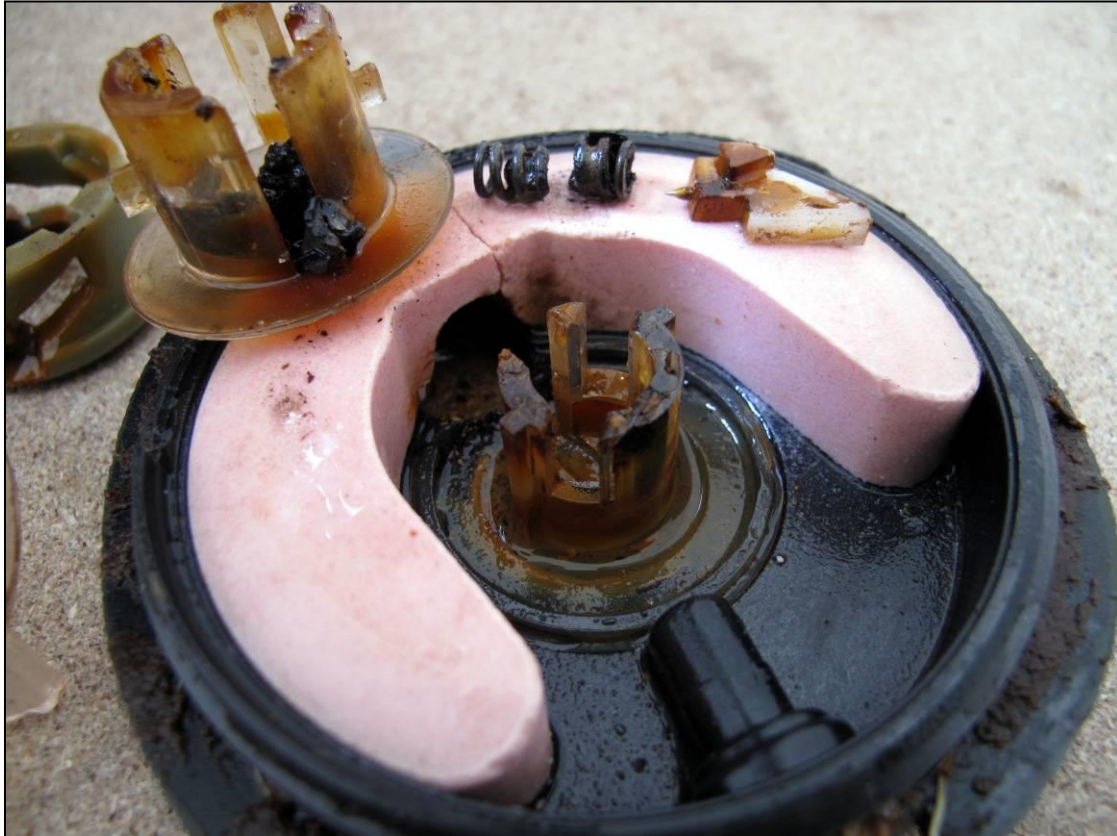
Only one of the recovered SB-33 mines contained a significant quantity of water; this was caused by the detonator plug not being screwed into place sufficiently tightly. The most obvious result of the water ingress was the disintegration of the striker spring, which would probably prevent the mine's fuze mechanism from actuating and might also make the mine more difficult to detect. The detonator capsule was also substantially corroded and possibly non-functional.

The badly corroded mine (shown in Figure 12) demonstrates the longer-term fate of all SB-33 mines, as rubber seals gradually deteriorate and permit water to enter the mine.

Figure 12: Inside an SB-33 which had been penetrated by water. The most likely cause of failure would be the disintegration of the striker spring, although degradation of the detonator capsule might also prevent the mine from operating. Note that the stainless steel firing pin is virtually unaffected

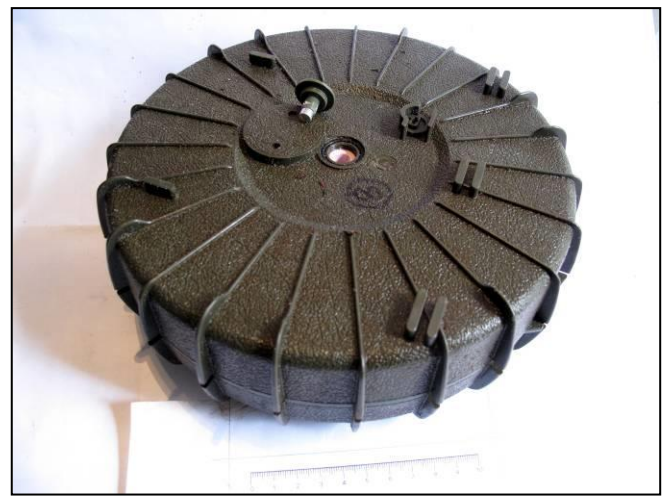
Figure 4: Base view of the SB-81

Examination of the casing and pressure plate showed that all of the mines had remained watertight. Where there was evidence of moisture on the inside, as with the SB-33, this appeared to be because the detonator plug (shown in Figure 4) had not been tightened sufficiently.

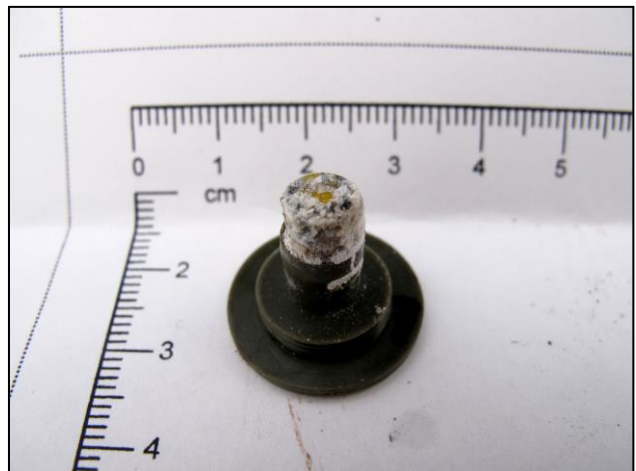
Figure 11: The yellow seal on the stab receptor appears to have been breached

The SB-81 uses the same detonator capsule as the SB-33, albeit in a different holder (Figure 10). Most were in good condition, but some, such as the one shown in Figure 11, showed obvious signs of degradation where they had become damp. It is possible that, in some cases, this had breached the seals of the capsule, particularly the thin yellow membrane covering the stab receptor. This is significant because the stab-receptive composition is likely to be affected by water, which may cause the mine to malfunction.

Since the casings have endured so well, the deterioration of detonator capsules represents the most likely cause of failure within the next few years. In the longer term, more water can be expected to enter the mines as rubber seals gradually deteriorate. In addition to affecting the detonators, this will also corrode the striker springs and cause failure of the fuze mechanism.
