Demining Programme Office in the Falkland Islands – Exploitation 2015

Submitted by: Fenix Insight Ltd

March 2015

FALKLAND ISLANDS LANDMINE EXPLOITATION – MARCH 2015

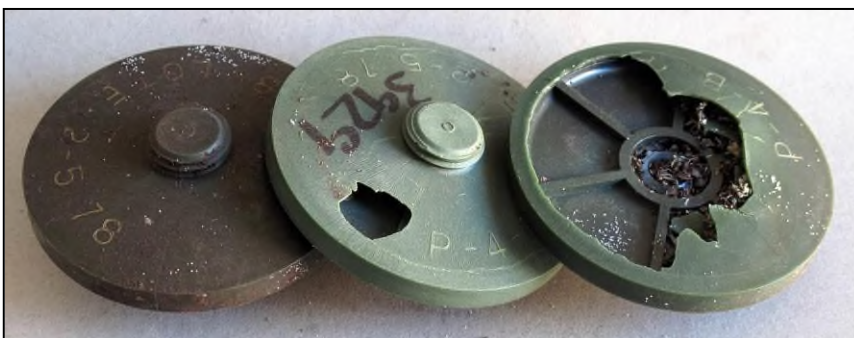
A significant proportion of the fuze casings had hardened and cracked, with many partially disintegrated. The proportion of degraded fuzes recovered so far during Phase 4A is substantially greater than on previous phases.

In examples where the top of the fuze casing had broken away, the striker spring and spacer were often missing altogether, leaving the mechanism incomplete. This means that the fuze could no longer function as designed.

A range of degradation was present among P4B fuze casings

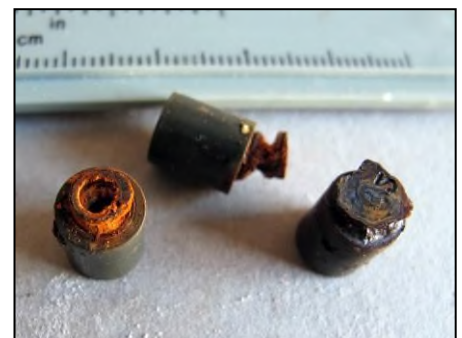
Any corrosion of the striker spring reduces its metallic mass and makes it even less detectable.

Many springs were corroded

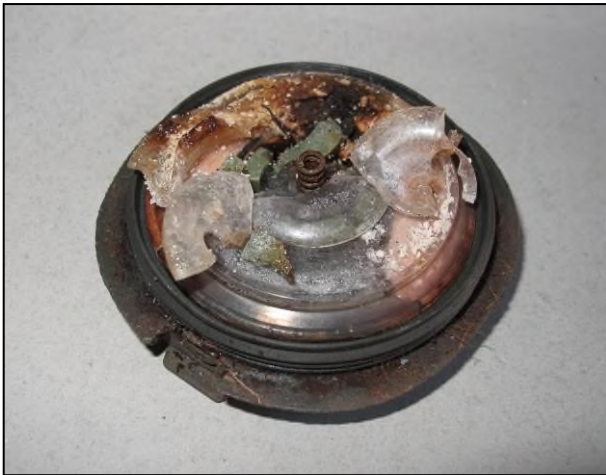
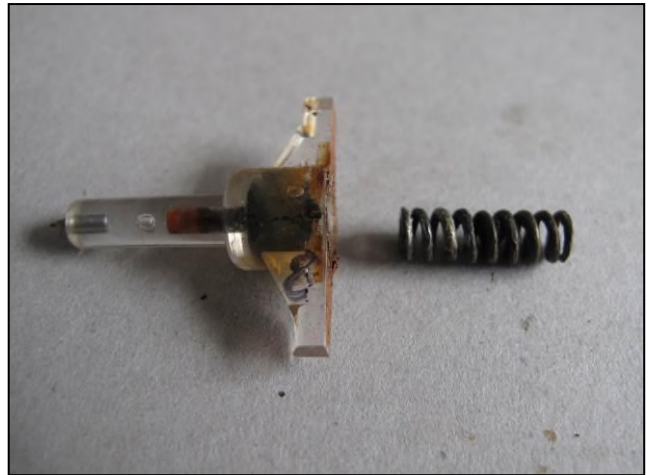
Even where water had entered the mines, rusting of the striker springs was generally light and superficial. This means that the metal content of both mine types still remains well above the detection threshold.

Even when rusted, the steel springs had lost little of their original mass (SB-33 left, SB-81 right)

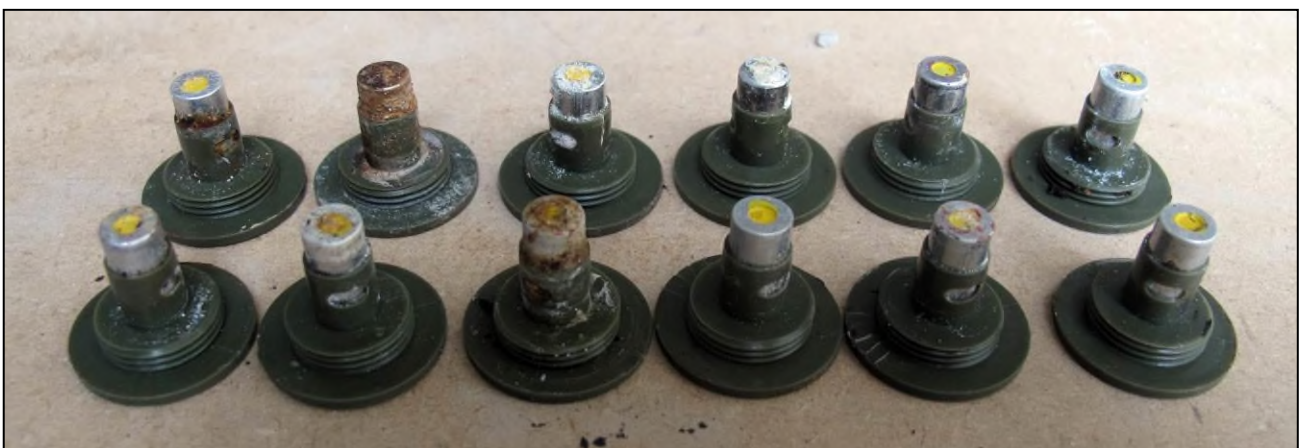
Most detonators appeared to be in good condition; however, some had white crusting (probably aluminium oxide from the detonator capsule) while others had a brown gelatinous exudation from the stab receptor.

Detonators from the SB-81 mines, some of which show signs of deterioration

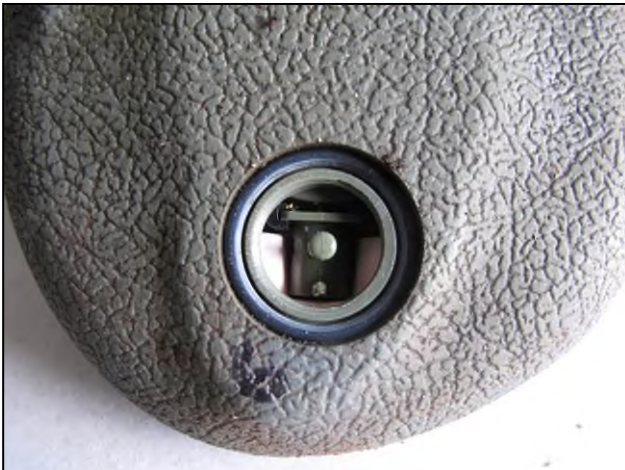
The presence of the firing pin in the stab receptor of the detonator is a major and unexpected hazard, since further movement could cause initiation. During disarming, the detonator is withdrawn from the mine body at right angles to the firing pin, meaning that the two components scrape together. If the detonator is still active, this could initiate the mine in the hands of the deminer.

An SB-33 detonator plug removed to reveal the detonator still in position, impaled on the firing pin

- Trials are arranged to assess the feasibility of using GPR for the detection of the P4B.
- No attempt should be made to defuze SB-33 mines in the field.
- SB-33 mines should be recovered, fully fuzed, and demolished within the minefield. A special demolition procedure should be developed to ensure complete destruction.
- Scientific analysis should be conducted to investigate the changes occurring within the mine detonators, including the causes.
- The effects of ageing on recovered mines and other significant ordnance⁴ continue to be monitored in future phases.
- Further data are needed on the location and circumstances of recovered mines in order to understand the factors affecting their condition. All contractors and authorities involved in demining operations should consider ways to collect such data without impeding clearance work.

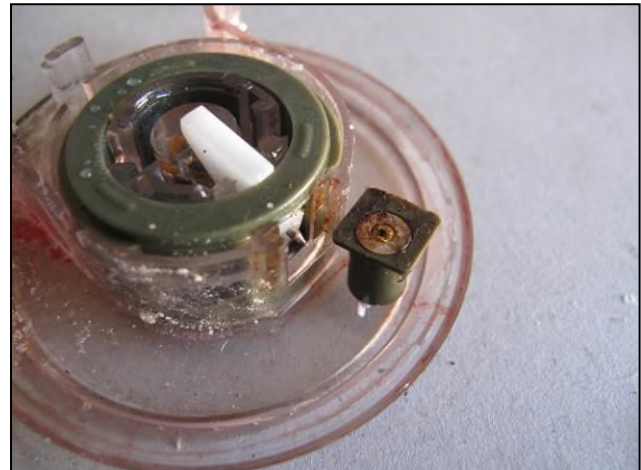
The gradual decline of detonators within SB-33 mines was also apparent from mines that had failed to fully function when actuated. Of the 16 mines examined, 6 had the firing pin embedded in the detonator, which did not initiate.

An SB-33 disassembled, showing the pin in the fired position and a hole visible in the detonator

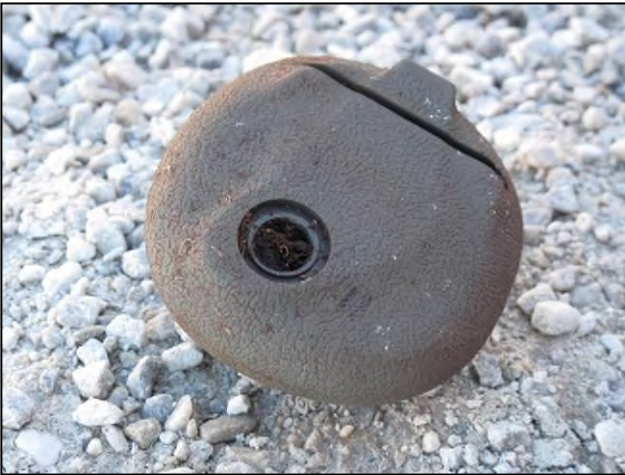
A further 4 mines were recovered with no detonator plugs present. It was initially assumed that these mines had been laid unarmed, without plugs, but examination showed that all had been actuated.

Several SB-33 mines had detonator plugs missing and were initially assumed to be unarmed
