Summary Report

Planned object: Mechanical mine clearance device

Model: MINEBREAKER 2000/2

Task: Clearing of life AT-mines (explosive up to 7,0 kg TNT) through the use of MINEBREAKER 2002 in the test area of the Military Technical Centre (WTD 91) in Meppen. Carrying out of acceleration measurements at the driver seat and execution of acoustic measurements.
Determination of the repair costs after the mine detonation.

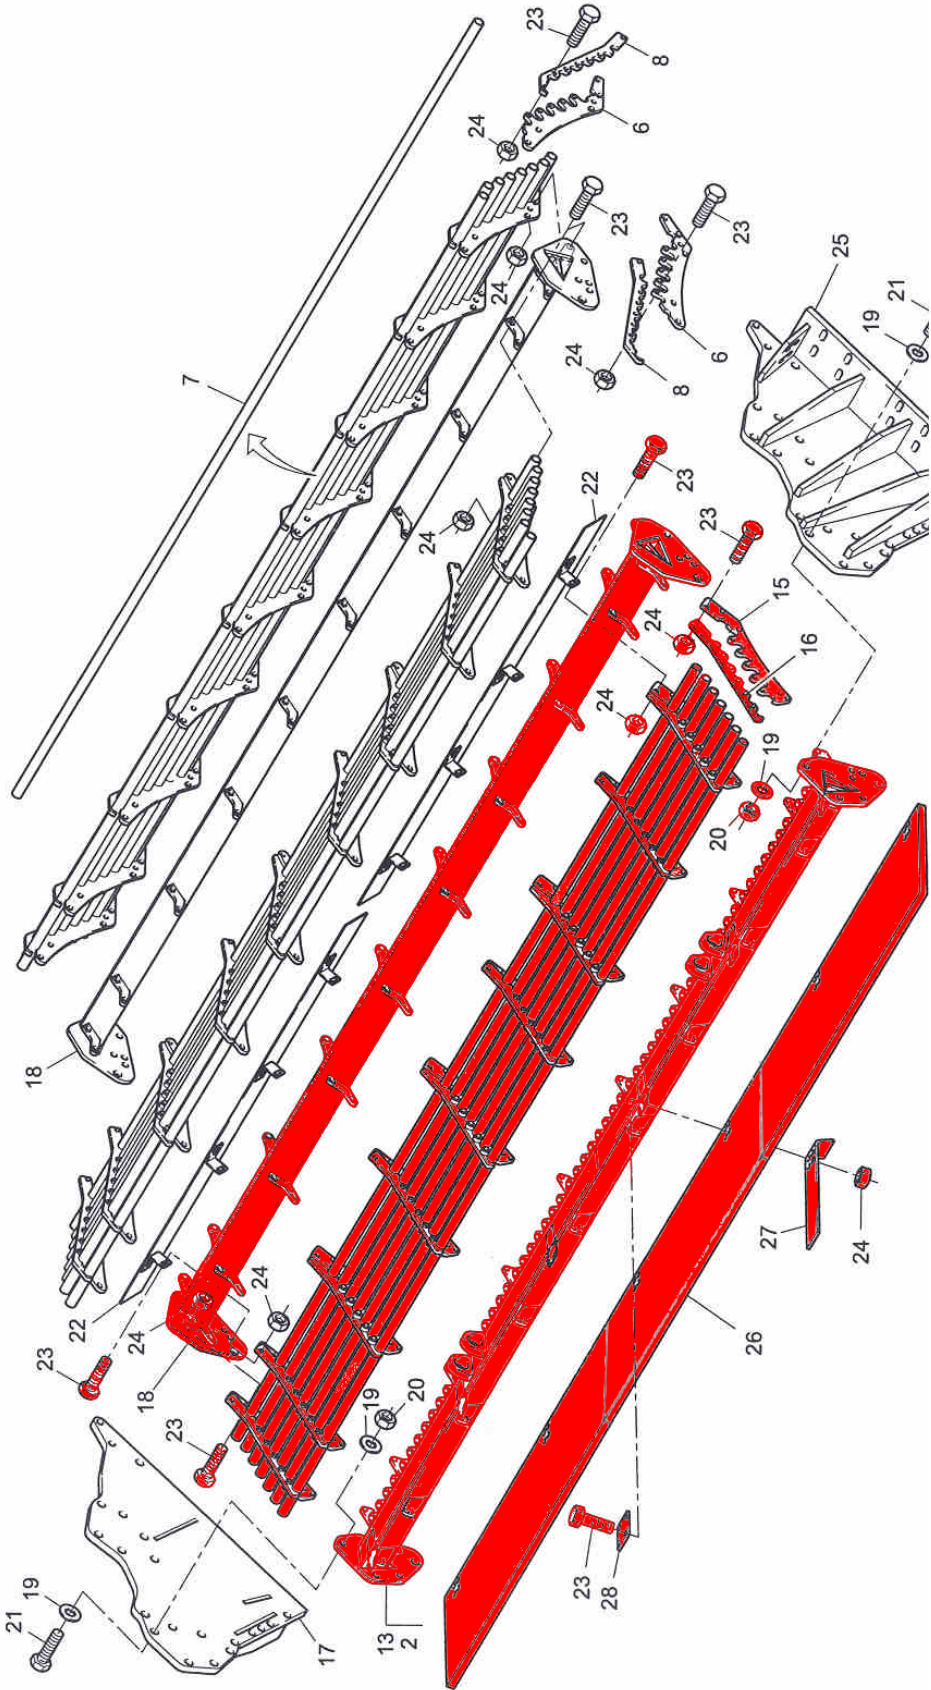
Immediately after the detonation of the third DM21 AT-mine, the damaged components of the tiller unit were replaced by new ones. Since the mines detonated within reach of the tiller drums, damages only occurred to the protective plates.

The following picture shows the replaced components of the protective plates in red.

The repairs were executed by 3 to 5 people, taking up about 5 h.

The presence of a crane and a forklift truck is needed during the repair process (this was not always possible during the trials).
