**CWA 15044 Test and Evaluation
of
Digger D-250**

May 2014.

**Capt. Johan Lönnefelt
Dir. of Research Curt Larsson
SWEDEC**

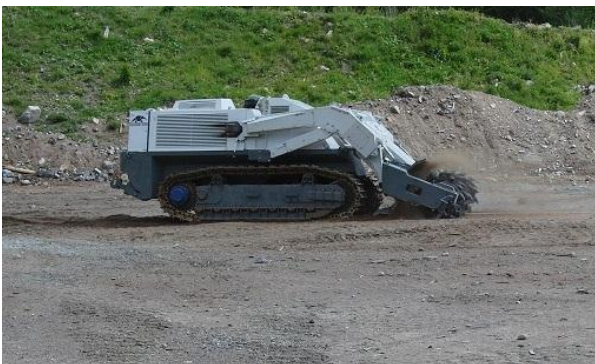
Figure1. Digger D-250

The Digger D-250 medium weight flail/tiller system (figure 1) is a remotely controlled (figure 2) tracked mechanical mine clearance machine, operated within visual line-of-sight by the operator.

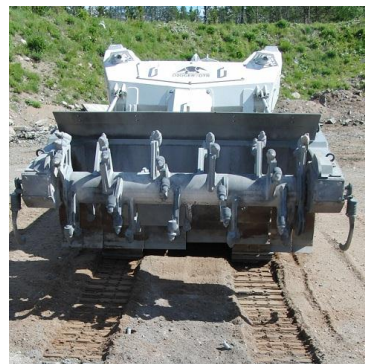
Figure 3. Tiller tool

Different tools (tiller, flail, manipulator arm, and gripper) can be attached to the Digger D-250. During this test the Digger D-250 was only equipped with the tiller tool (figure 3).

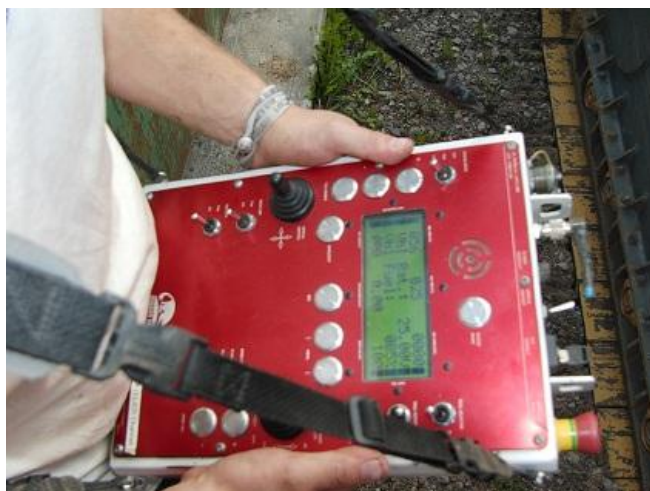
Figure 2. Remote Control

The operator controls the machine from a man-portable transmitter unit using visual observation of the machine.

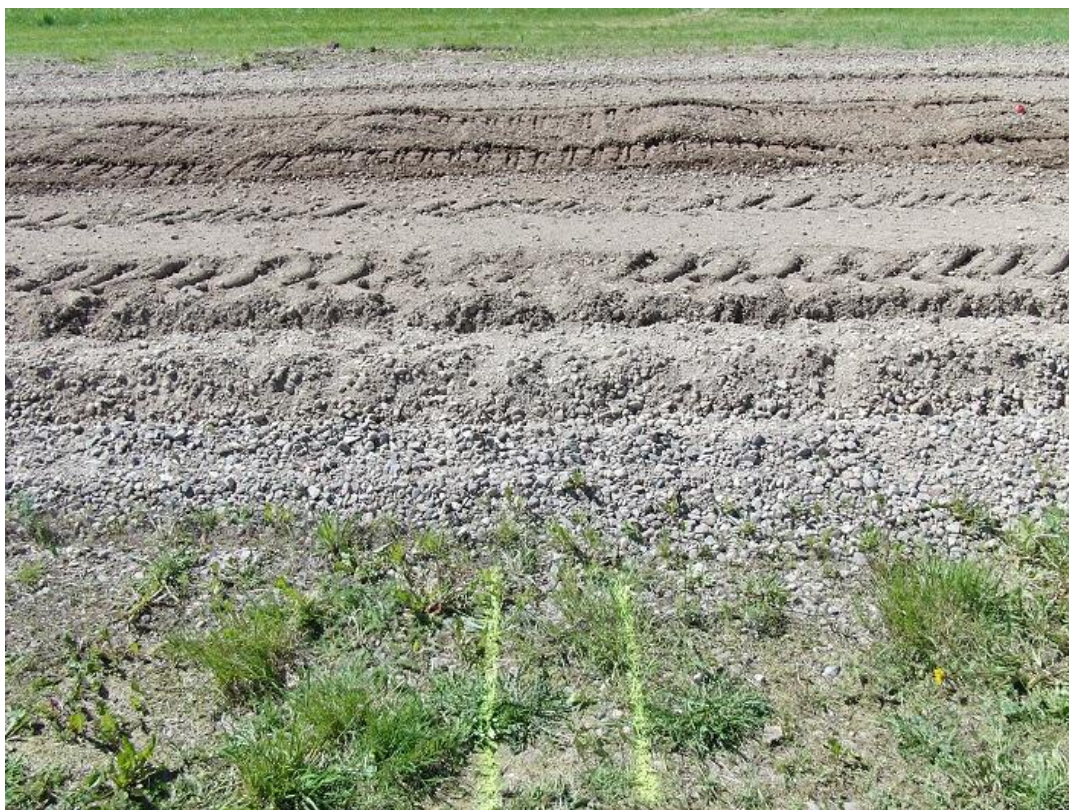
Figure 4. Oscillations on surface after the machine in the gravel lane.

First assumption for the result (non-triggered detonators) could have been that the automatic control system was not always able to maintain the digging tool in a constant position. Consequently, the oscillating depth variations of the digging tool could then have affected the result, see figure 4.

To shortly summarize what was observed seeing the bumps in figure 4, is that the oscillations don't seem to have any real impact on the clearance result. On the other hand the "edge hit" phenomena can be seen in the numbers because when a mine isn't well maintained in the ground like in sand 0cm. This was also when more escaping mines were observed. From that point, if one goes deeper one gets less live mines and if one goes for harder grounds the mine will be better maintained. One can also see this in the numbers from sand (6 live) to gravel (2 live) to top-soil (1 live). The conclusion is that the "edge hit" phenomenon is the likely reason of why mines are escaping.

All boards had a straight penetration down to 10 cm or below. An observation is, recalling the earlier discussion concerning oscillations on the gravel surface after the machine (figure 4), is that one cannot see any indications of that phenomena on the witness boards.

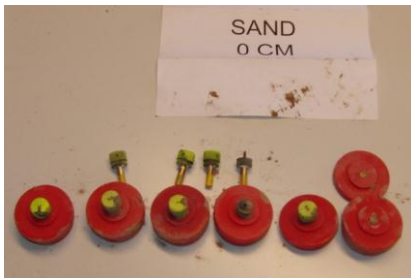
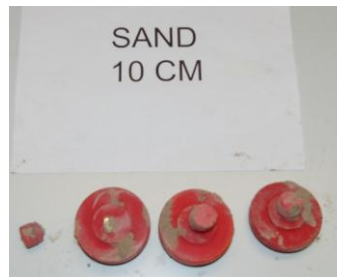
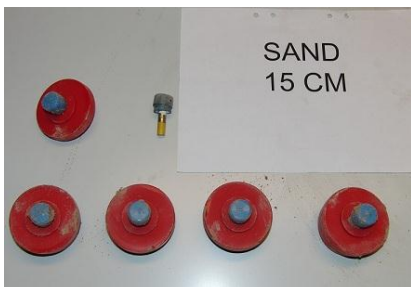
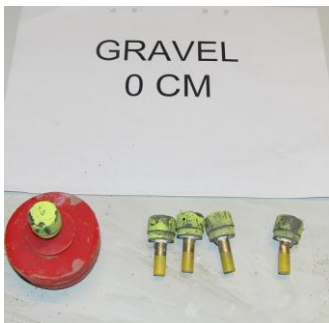
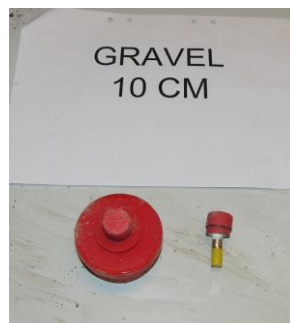
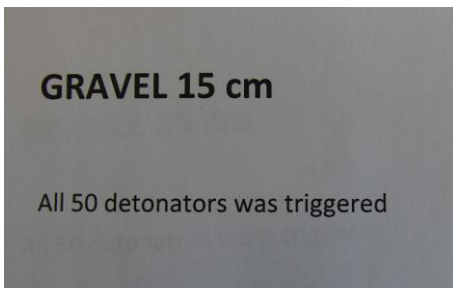
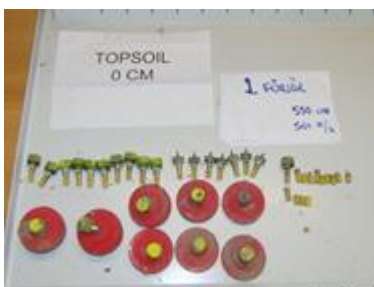
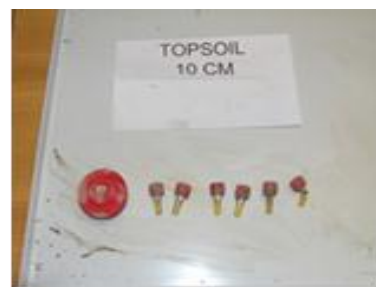
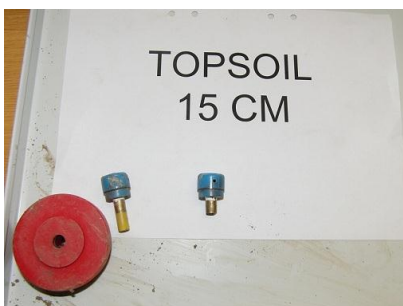
After each test in the series, the test lanes were searched as described above, and the materials of interest were assembled and inspected. These materials included detonators, detonator components, intact mine targets, and mine bodies with most of or the entire (inert) main charge intact. The photos in figures 5-13 show the collected debris.

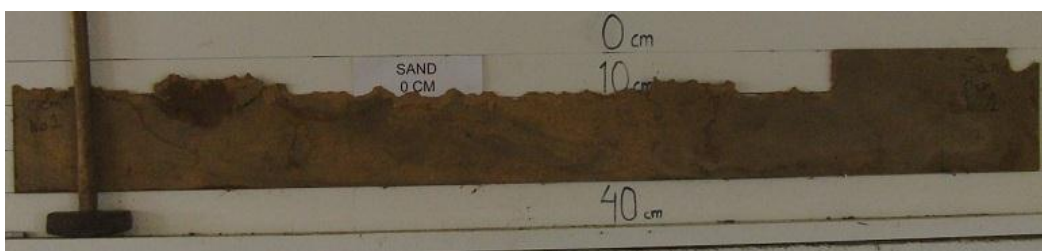
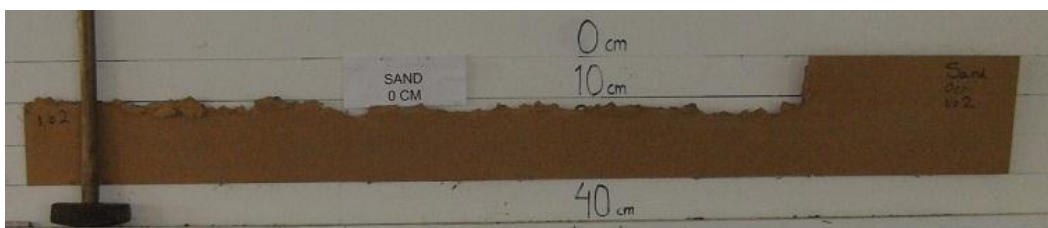
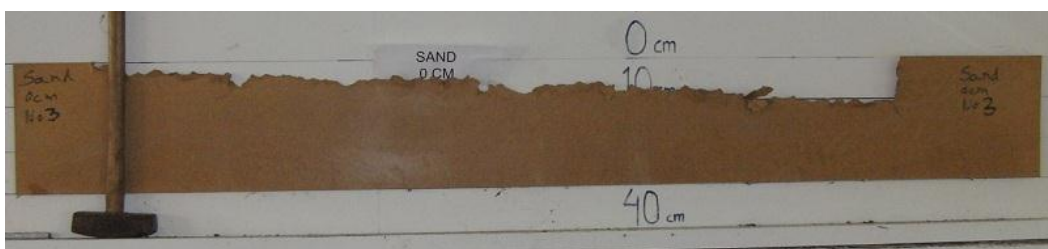
The first board shows some variations over the width. The second board had a depth down to 9 - 13 cm. However board three shows more depth variations between 2-3 cm and down to 10 cm. This is a large variation during the length of 25 m between board one and the third board. The tiller tool seems to be digging more on its right side than the left. This typically happens in side slopes variations terrains. The left track goes on a bump and the entire tiller rotates laterally. But this situation has been observed for all machines that have no roll angle correction between the tool and the prime mover. This lane also shows some bumps on the surface but it is not visible on the fibre boards.

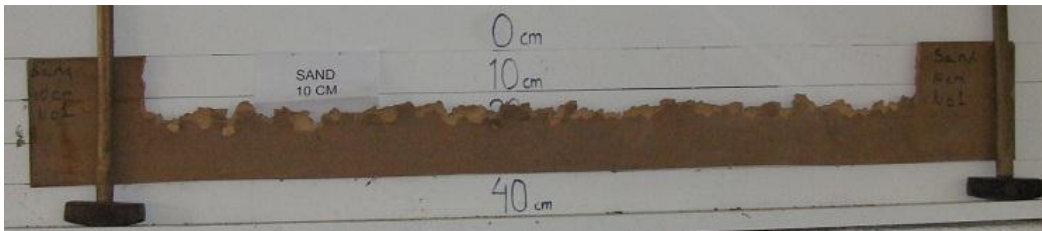
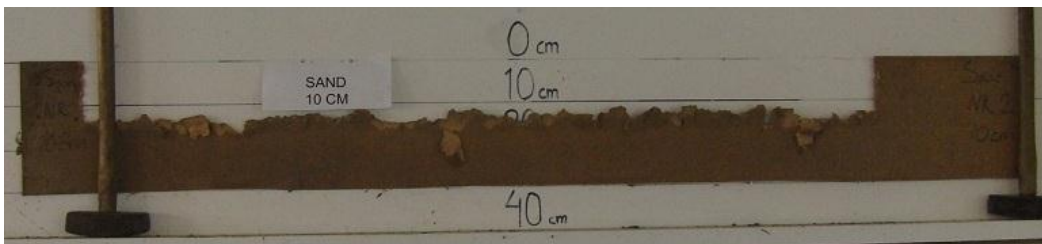
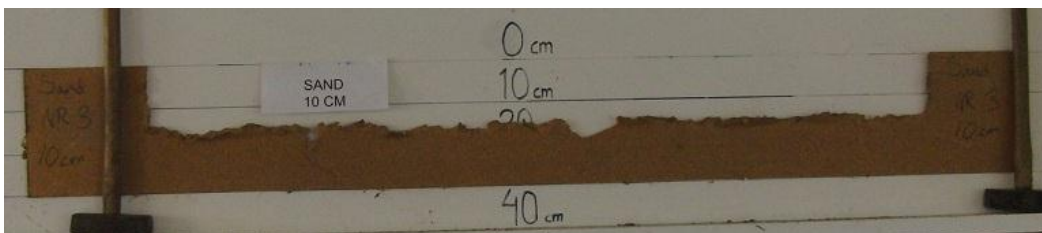
The clearance depth was down to more than 10 cm. The cutting profile is straight and horizontal.

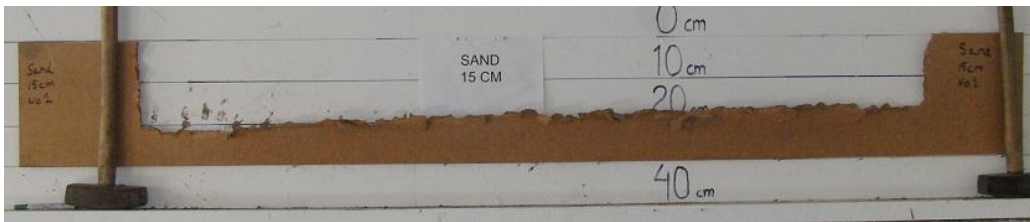
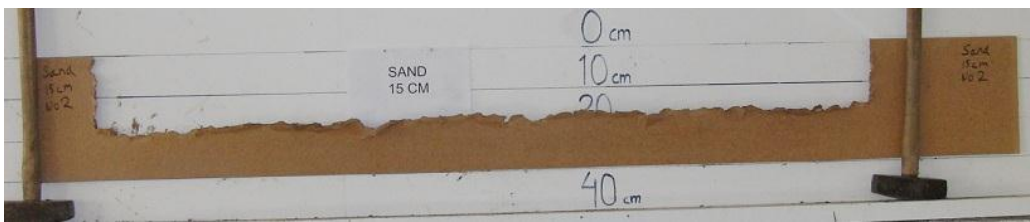
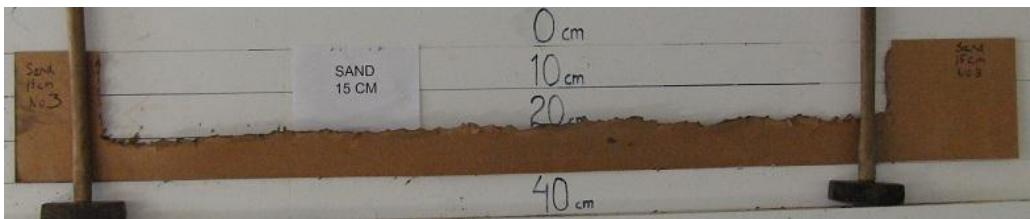
The clearance depth was down to 15 cm or more. A slight right to left side inclination can be seen here.

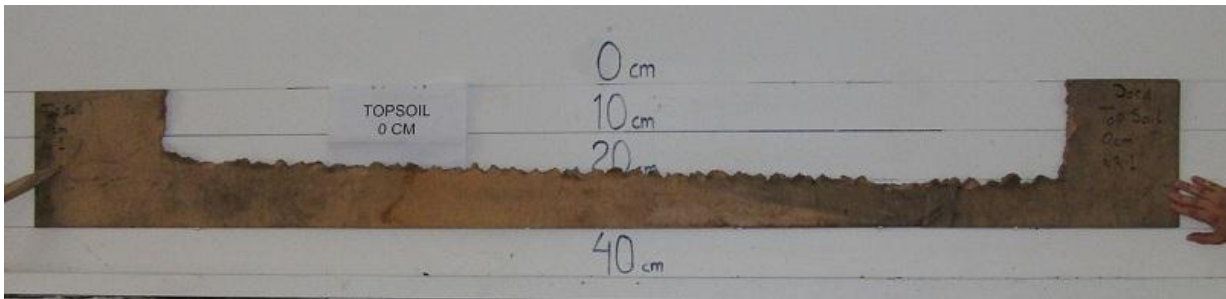
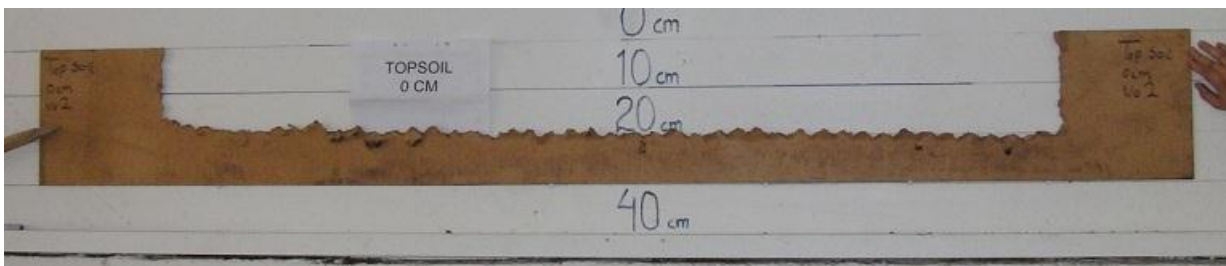
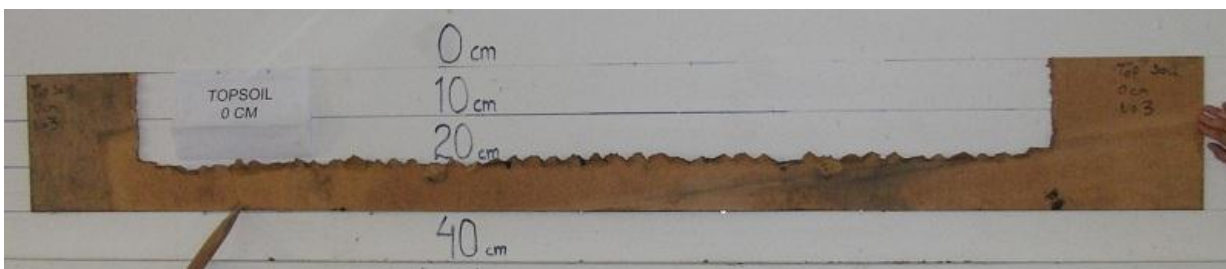
Clearance depths down to 15 cm or below. However two of the boards (first and second) show an inclining line from left to right.

On some of the witness boards an inclination is shown. Almost all of the inclined profiles were observed in the topsoil lane (except the last for sand DOB=0 cm) and this behaviour is observed on each depth. While doing topsoil DOB=10 cm, it was raining and for topsoil DOB=15 cm the soil was quite wet due to the rain during Sunday. This inclination could be explained if the soil is getting more muddy on the right side of the lane because then, the right track is going deeper in the ground and the whole machine inclines on the right side.

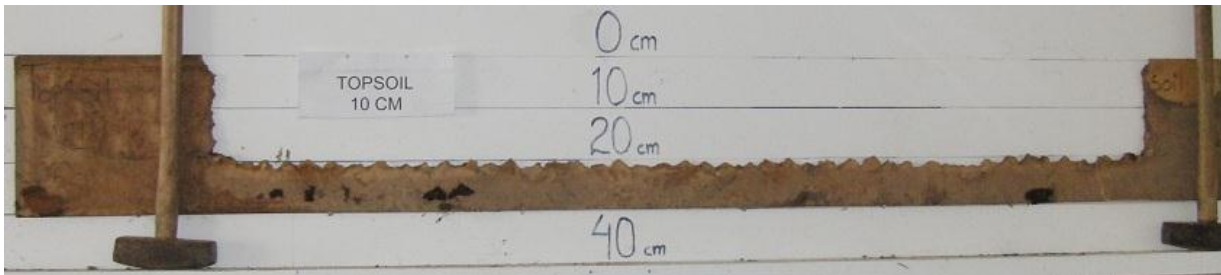
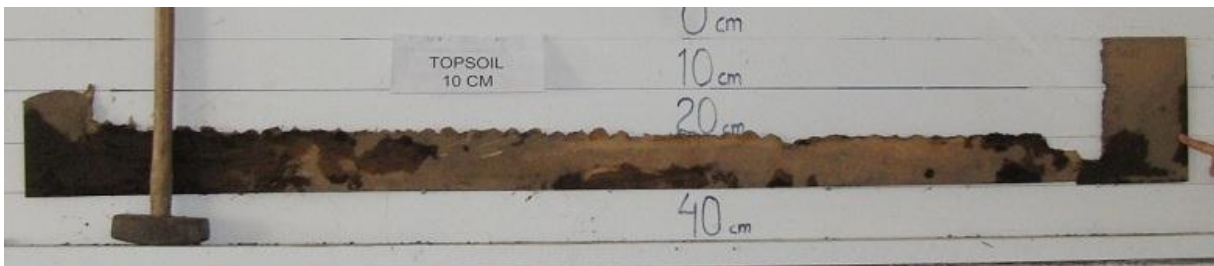
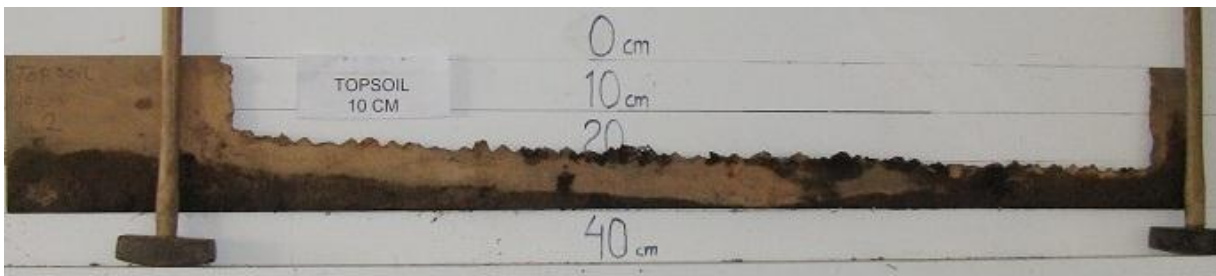
The first board shows a penetration depth down to 20cm. Board two and three had a depth down to 15-20cm. Two of the boards had a straight profile while the third shows an inclination from left resulting in a clearing depth between 12-20 cm.

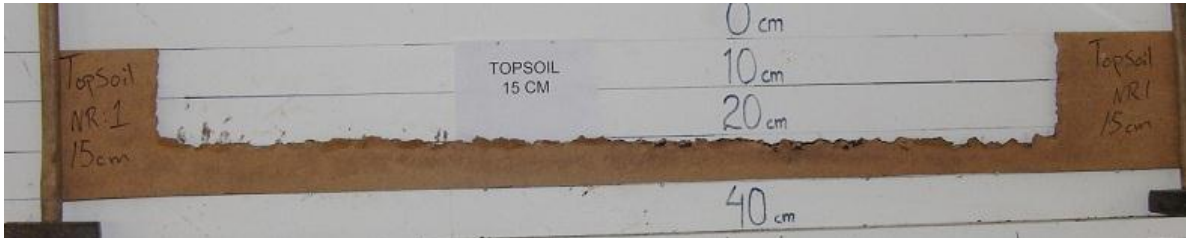
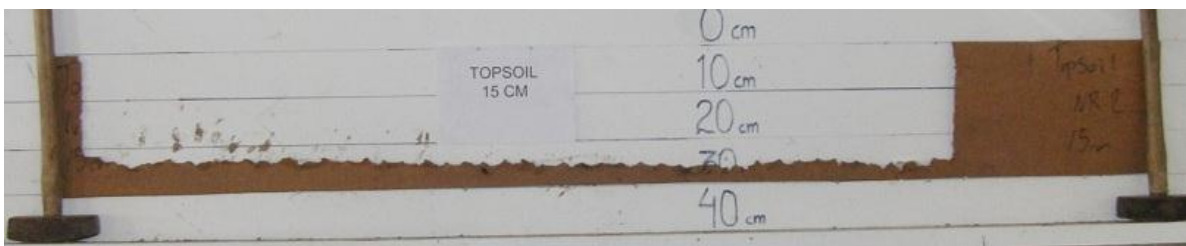
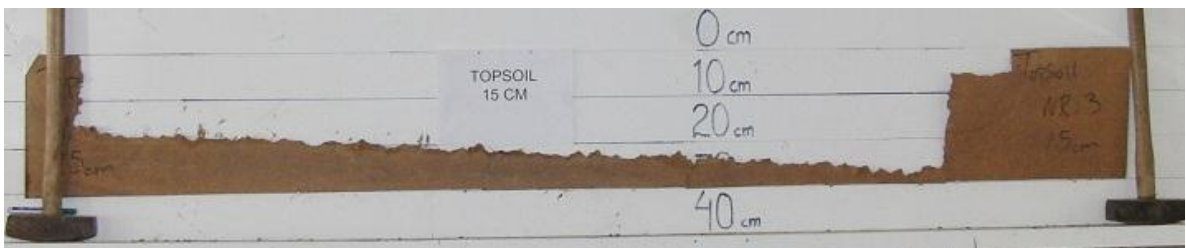
The first and the third board had a penetration down to 20-25 cm; the second board had a penetration down to 27-28 cm. The third board was penetrated down to 15-27 cm. All boards show some inclination from left to right.

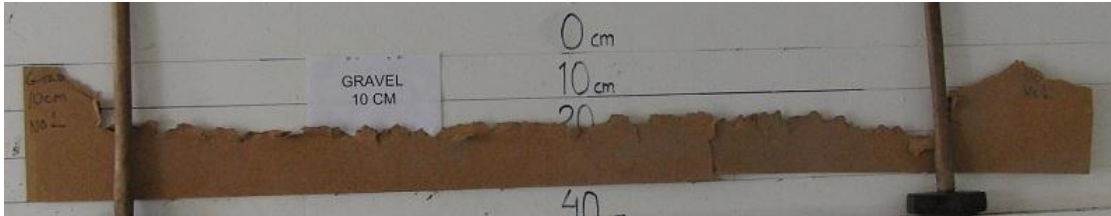
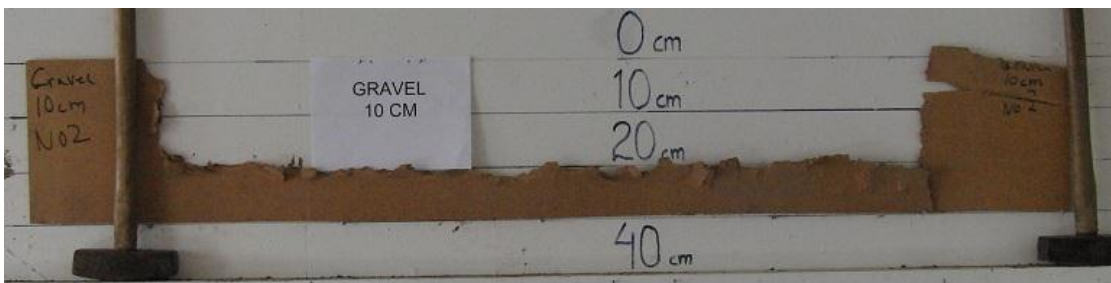
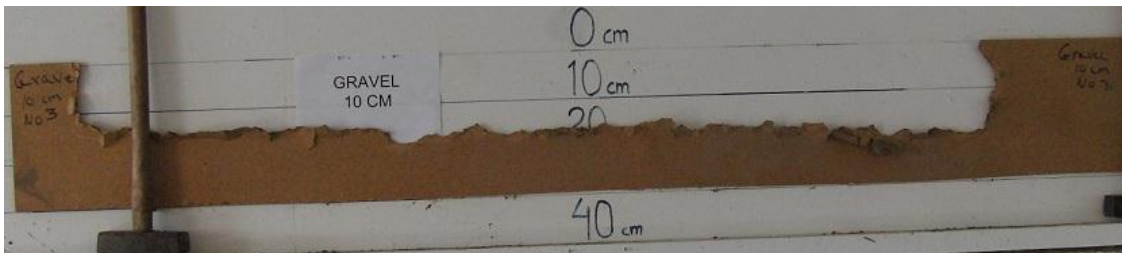
All boards had a straight penetration well below 10 cm

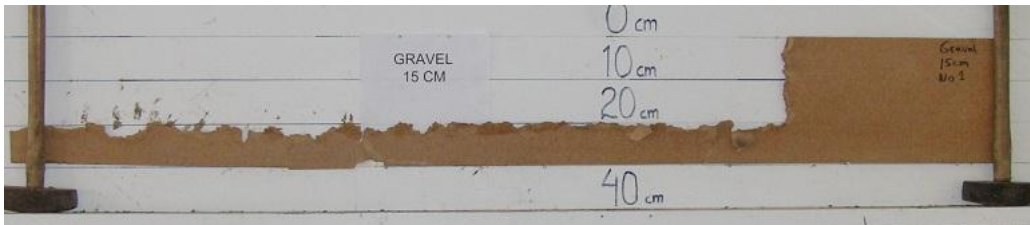
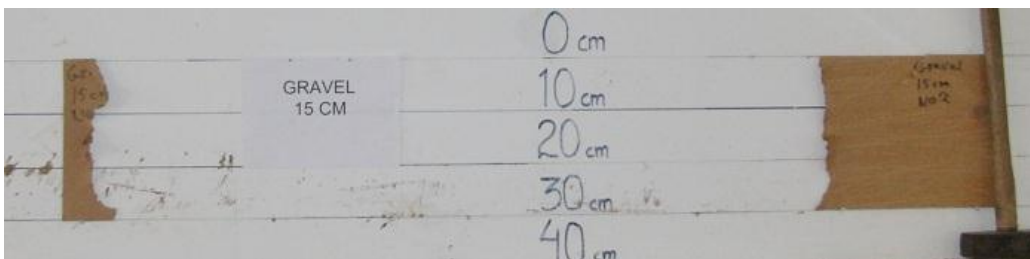
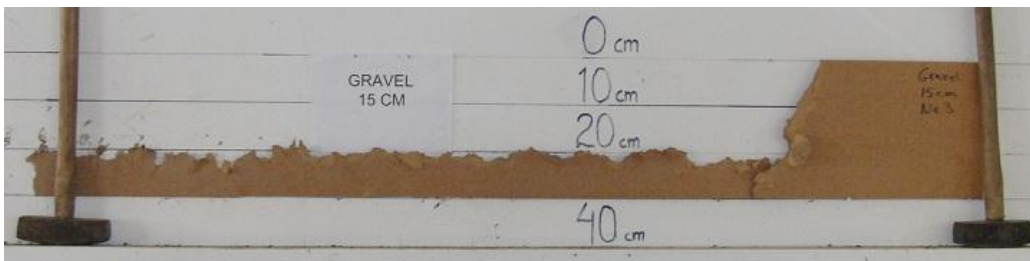
All boards had a straight penetration down to approx. 20 cm. However since the machine doesn't dig deeper than 25 cm (at 25 cm the tool frame is on the ground surface) a piece of the witness board in figure 39 must be missing.

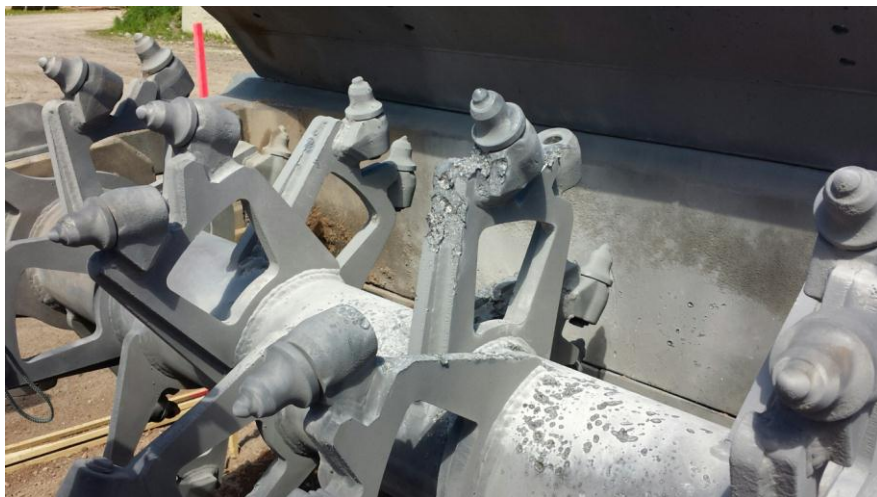
Figure 41. Results after detonation number 1. 5 kg AT-mine.

The result after the first AT mine of a 5 kg AT-mine was that the detonation had impact on the tiller tool without damaging the other parts of the machine. The

tiller shaft was bent and had some damage. This shaft had a single layer of 12 mm Hardox steel. If one had chosen to continue using this tiller tool the bending would cause damages on the belt drive.

The manufacturer decided that it was not possible to repair the shaft and replaced it with a new and stronger one (12 mm Hardox steel in two layers). However the frame of the tool was not affected. The machine itself, except for the leakage, showed only smaller damages from metallic scatter.

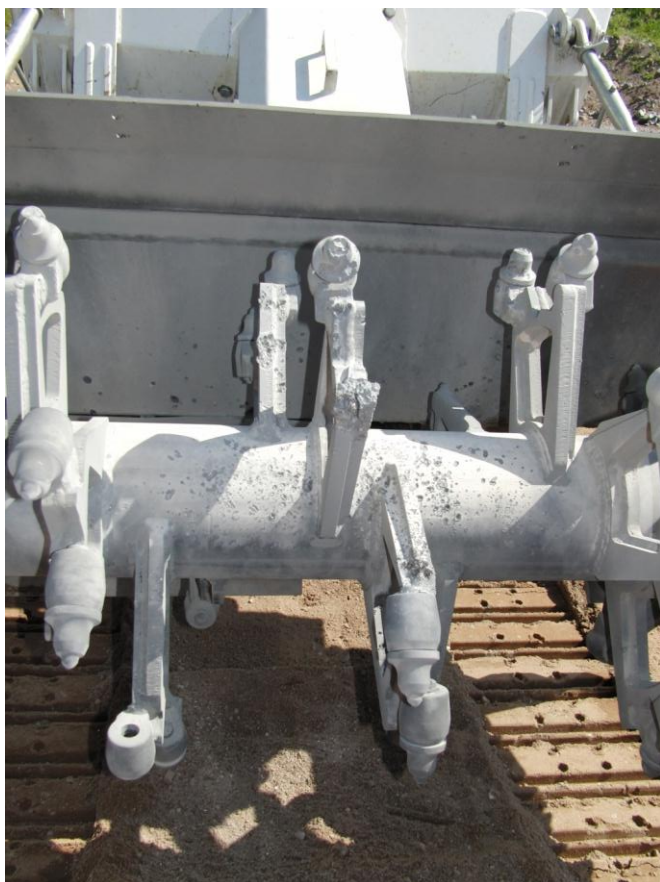
Figure 42. Results after detonation number two. 5 kg AT-mine.

The result after the second 5 kg AT mine detonation was fragmentation marks on the tiller and one of the tooth supports was broken off. Two teeth were loose. The shaft was intact without any bending. New tooth support was welded on the shaft and everything was checked and ready after two hours. Some small oil leakage from the hydraulic system was also observed.

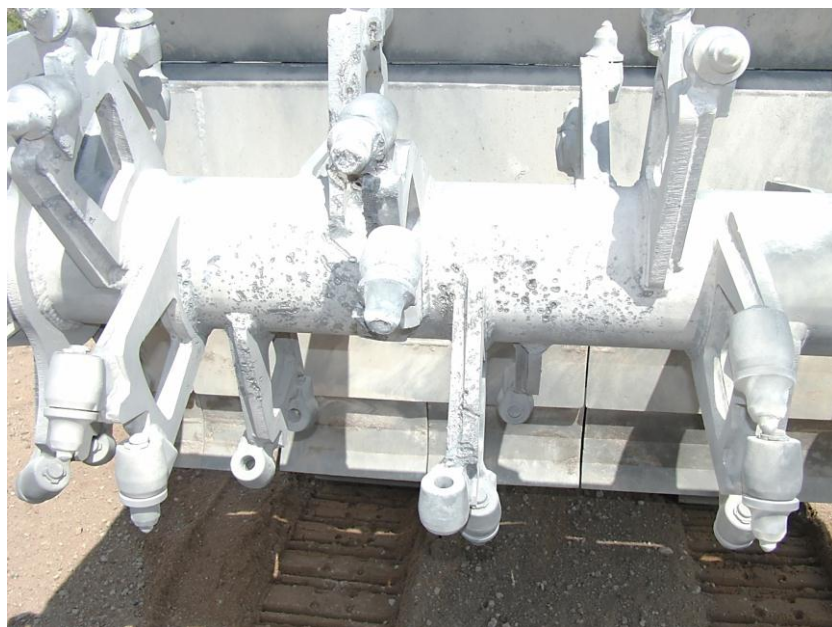
Figure 43. Results after third detonation. 8 kg AT-mine.

Then the machine was tested against the CWA stipulated 8 kg mine resulting in more damages on some parts of the tiller which was repairable. However more oil leakage of hydraulic oil caused by un-tightened hydraulic adaptor. After tightening it the leakage stopped. The Digger D-250 could be driven itself from the site by the operator.

After four hours of repairs of hydraulic system, the teeth supports including welding and replacement of missing teeth the machine was ready for use again.

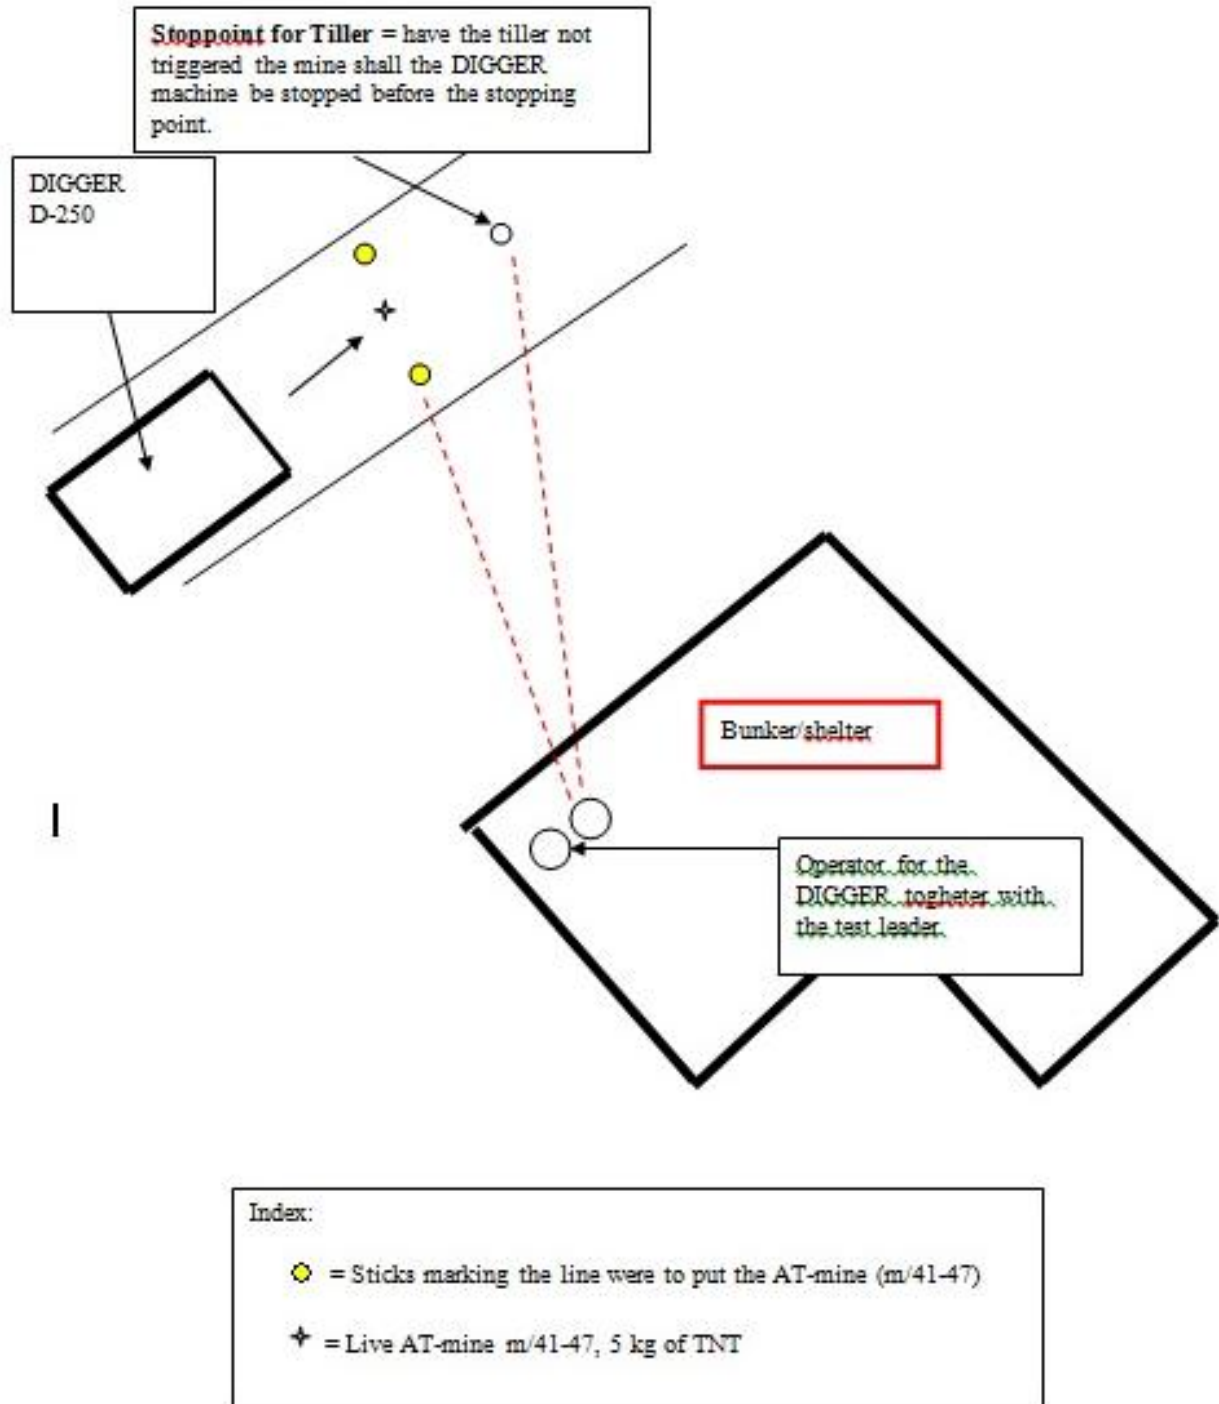
Figure 44. Sketch showing the arrangement for the survivability test with the D-250 at Demolitions Site no.1, Eksjö.

The test facilities for survivability testing near Eksjö have been used to test different types of equipment in recent years. The blast range includes a gravel bed 4 m wide and 20 m long. The bed contains compacted sand. The lane is located at an angle of about 75 degrees from the safe house. The operator manoeuvres the machine from the safe house and can decide both forward speed and course. The Digger D-250 did clear three Anti-Tank mines with the tiller. One high speed camera was used during the tests.

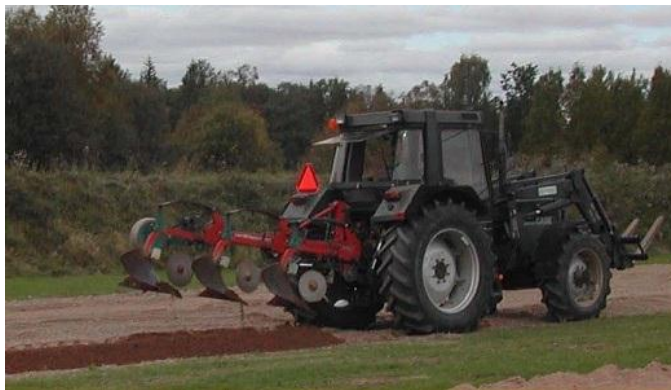
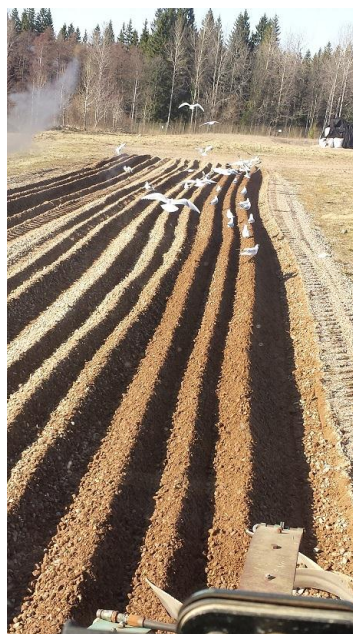
Figure 45. Preparations of test lanes. Step 1 - Ploughing the lane.

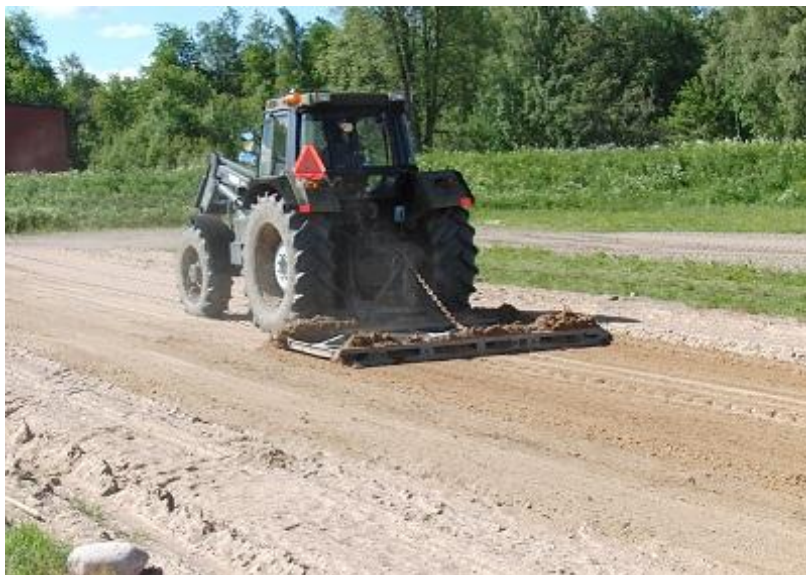
Figure 46. Step 2 – Running over the lane with a clod-crusher.

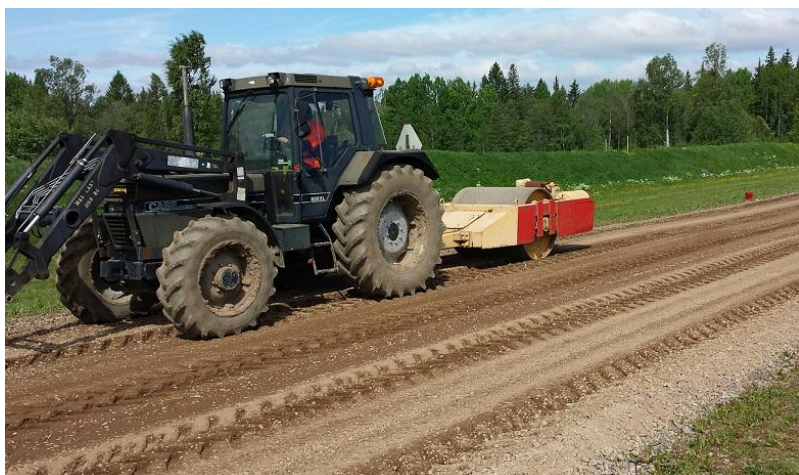
Figure 47. Step 3 – Compacting the lane

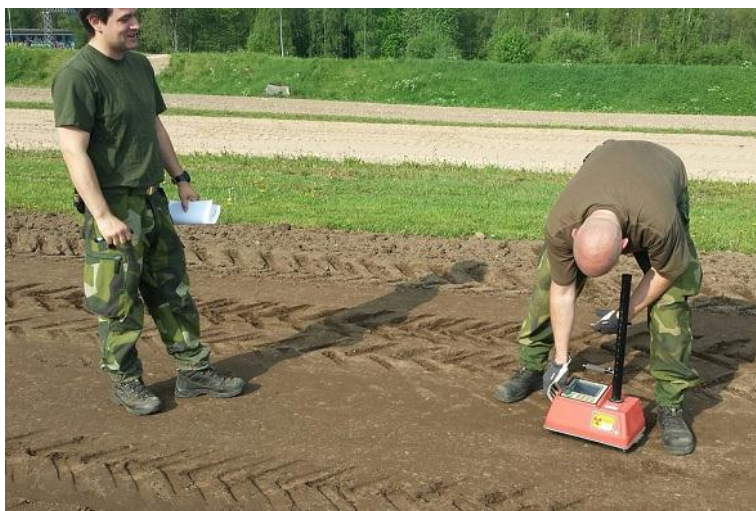
Figure 48. Step 4 - Measurement of compactness and moisture content.

The test facilities at Norra Kulla, near Eksjö, have been used to test various types of equipment in recent years. The site has three soil environments specifically for performance tests. Parallel lanes 5 m wide and 100 m long provide compacted sand, compacted gravel and compacted topsoil. The sand and gravel lanes are easily replicated almost anywhere. As the characteristics of topsoil may vary from one location to the next, data from the topsoil lane may not be quite as repeatable. The soil in each test lane is prepared as follows. Prior to a test the soil is loosened with ordinary agricultural or construction equipment, and then compacted using the vibratory compacter as shown in Figure 45-47. The soil compaction and moisture content are monitored until the compaction reaches a defined level for that soil type. Compaction and moisture content are measured using the CPN International model MC-3 Portaprobe, figure 48.

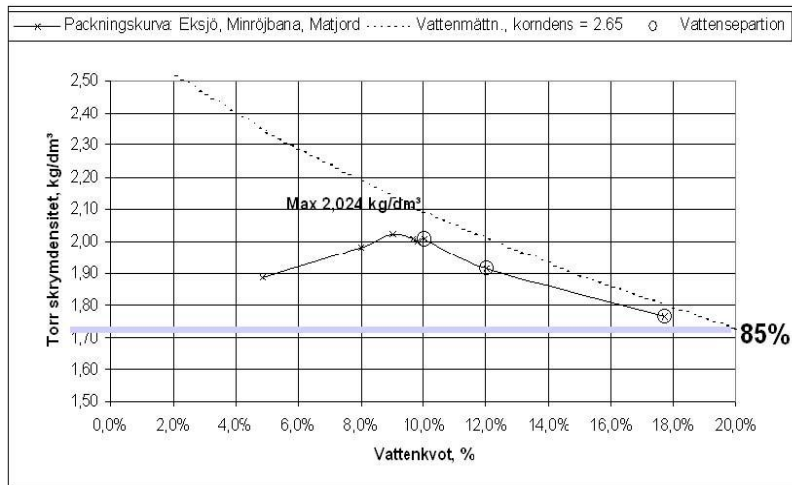
Curve chart Topsoil

An example of a soil analysis for the topsoil is shown in Figure 49. In this Swedish language chart, the horizontal axis refers to the moisture content (by weight), while the vertical axis shows the density, with a maximum occurring at $2,024 \text{ kg/dm}^3$. A 95 % compaction level (approximately $1,9 \text{ kg/dm}^3$) can only be achieved with soil moisture contents between 6 % and 12 %; this might restrict testing if the moisture content were out of range on a given day. As a comparison, compacting the topsoil to approximately $1,7 \text{ kg/dm}^3$ results in the soil reaching 85 % of its theoretical maximum compaction level. For the topsoil this is a useful target since it can be achieved without undue difficulty, and also because it is achievable over a wide range of moisture contents up to 18 % or greater. Similar analyses were done to select the compaction levels for the sand and gravel areas. Target compaction levels for the three soils were:

Figure 49. Top soil compaction as a function of water content.

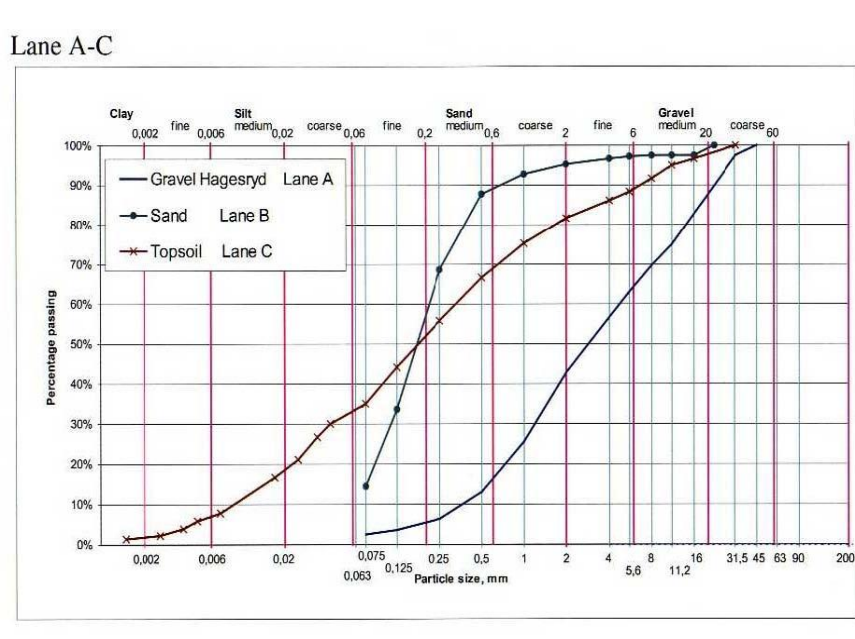
Samples from the sand, gravel and topsoil areas were analyzed to determine particle size distribution, with Figure 50 showing the results.

Figure 50. Particle size distribution

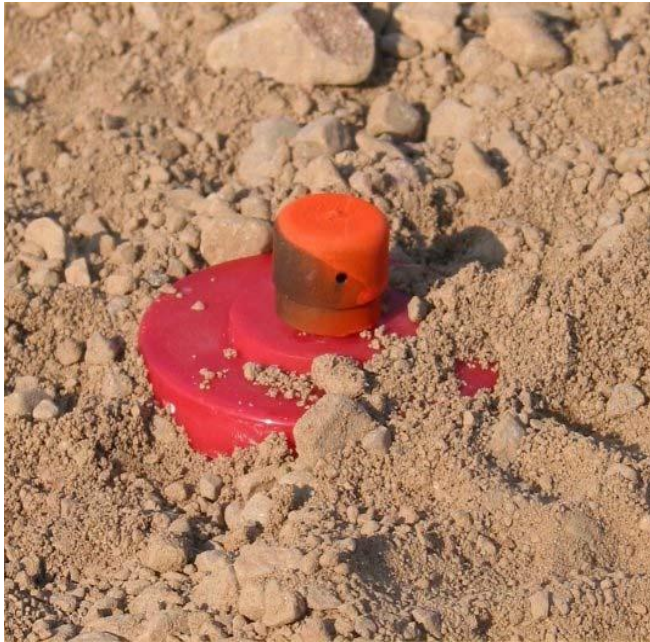
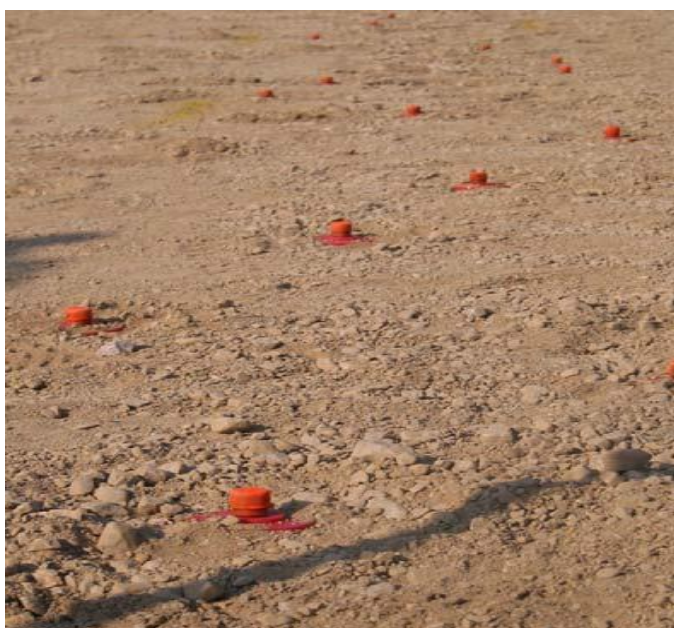
The test targets used in this trial were the standard SWEDEC mine surrogates shown in Figure 51 and 52. The targets make use of live detonators m/49B from the m/49 anti-personnel mine installed in inert, plaster-filled plastic bodies. These targets replicate many typical small antipersonnel land mines, which a machine might be expected to encounter.

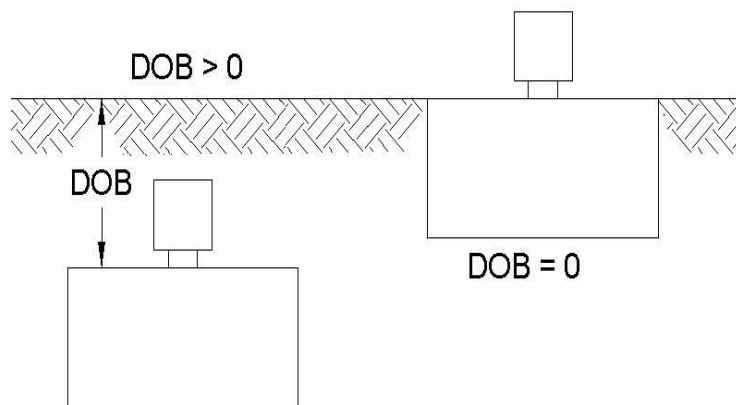
Figure 53

The depth of burial (DOB) is measured from the top surface of the mine (not the top surface of the detonator), to the ground surface. Hence, a burial depth of 0 cm is illustrated in Figure 53. To minimize soil disturbance, the tool shown in Figure 54 was used to pull out a soil core just slightly larger than the mine body. The live detonators are installed moments prior to the beginning of the test.

DOB – Subsurface DOB – Surf

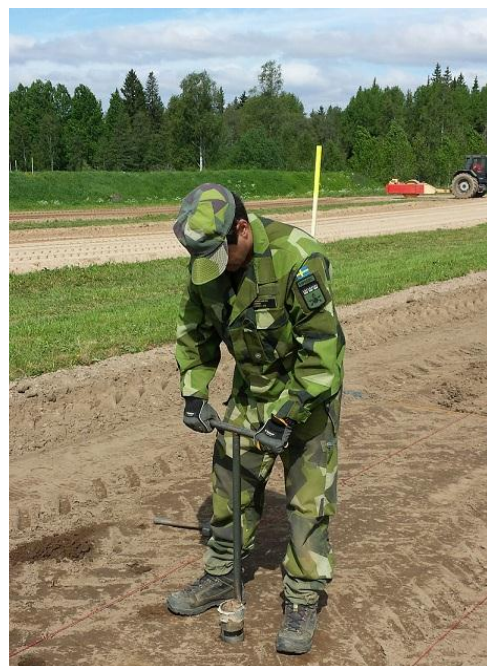
Figure 54. Tool for making holes.

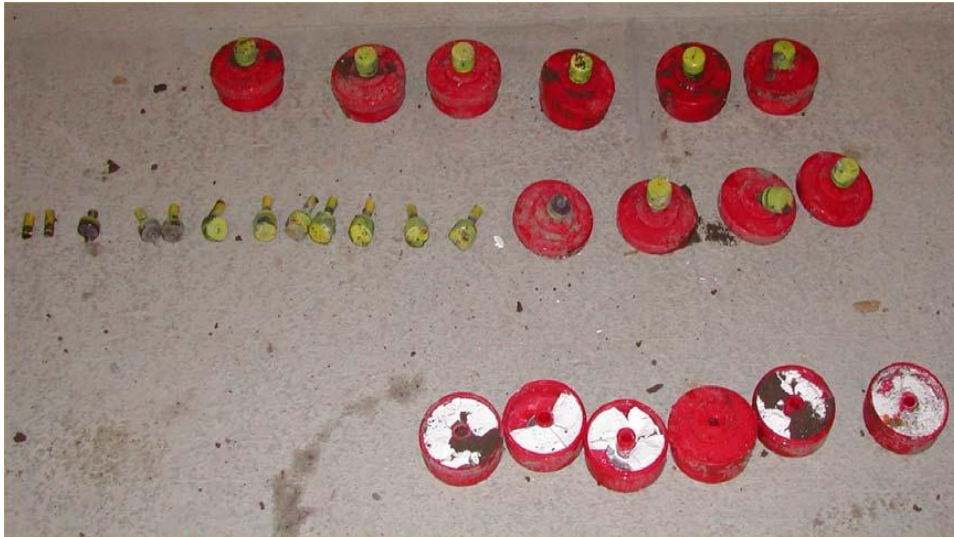
Figure 55. Examples of intact functional mines (top row), detonators separated from main charge (second row), and main charge separated from detonator (bottom row).

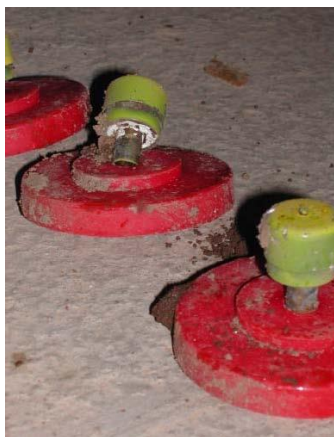
Figure 56. Detonators separated from main charge (left) and main charge separated from detonator (right).

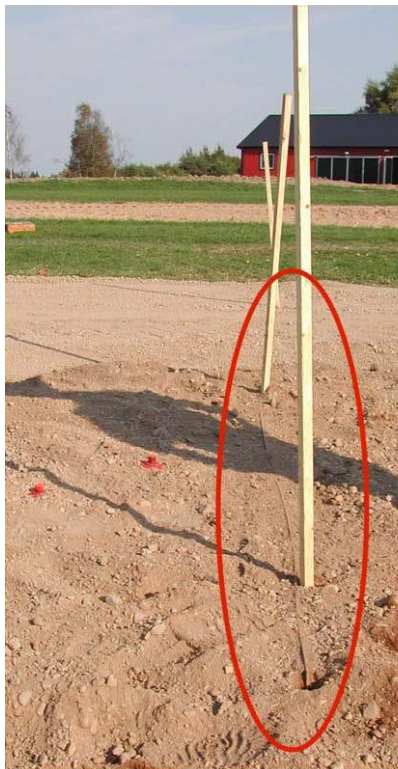
Figure 57.

Along with the mine targets, witness boards are installed at three locations across each lane. At the start, middle and end of each test area, 3mm thick, 300 mm height, 3 m long and oil hardened (water resistant) fibreboards are installed across the full width of the flail head. Buried flush with the surface as shown in Figure 57, the boards act as witness panels to record the depth of penetration of the tiller/flail tools. This technique does not record the force with which the tiller/flail tools strike, but it does give a clear, unambiguous indication of depth of

Ready For Test

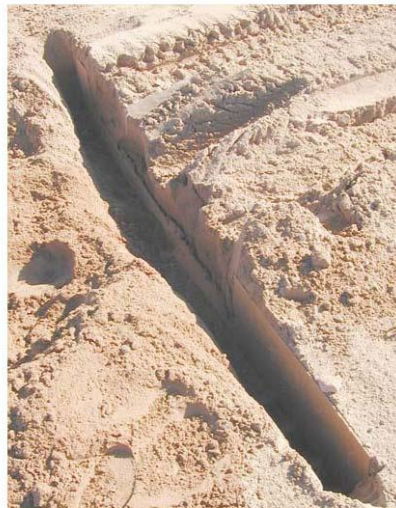
Figurer 58.

penetration. Figure 58 also shows a typical example of the witness boards after a test when some of the neighbouring soil has been removed to expose the boards.

After Test

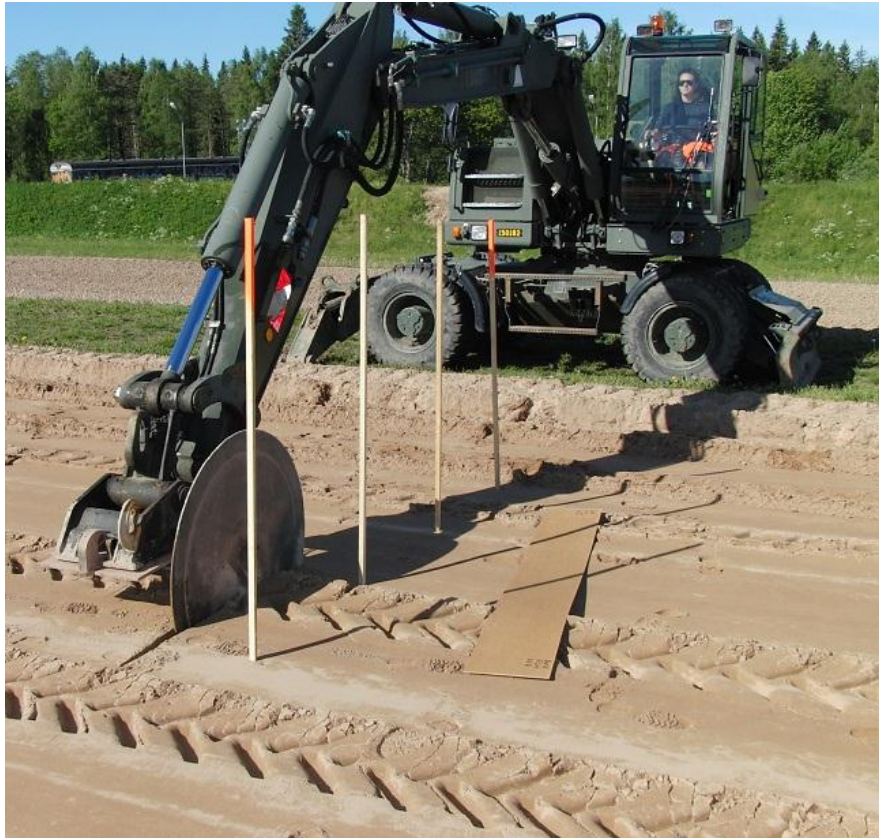
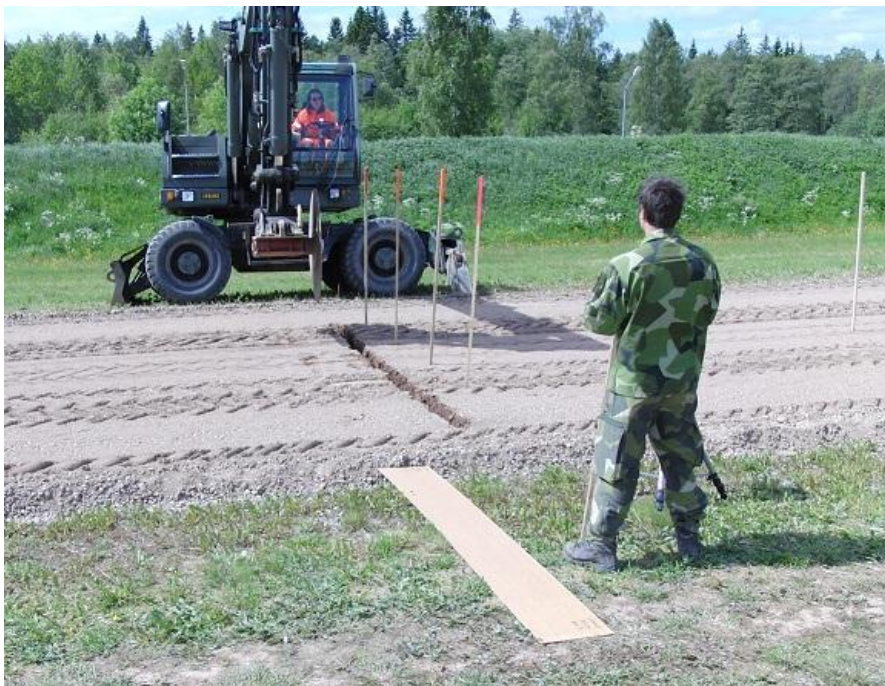
A simple “pizza cutting” tool was used when installing the witness boards quick and easy without excessive disturbance of the surrounding soil. This tool, shown in figure 59, works very well in sand, topsoil and gravel.

Figure 59. Preparing for planting a witness board.
