Summary Report

Planned object: Mechanical Mine clearance device

Model: MINEBREAKER

Task: Establishment of mine test lanes in two distinctly different types of soils and execution of clearance trials.

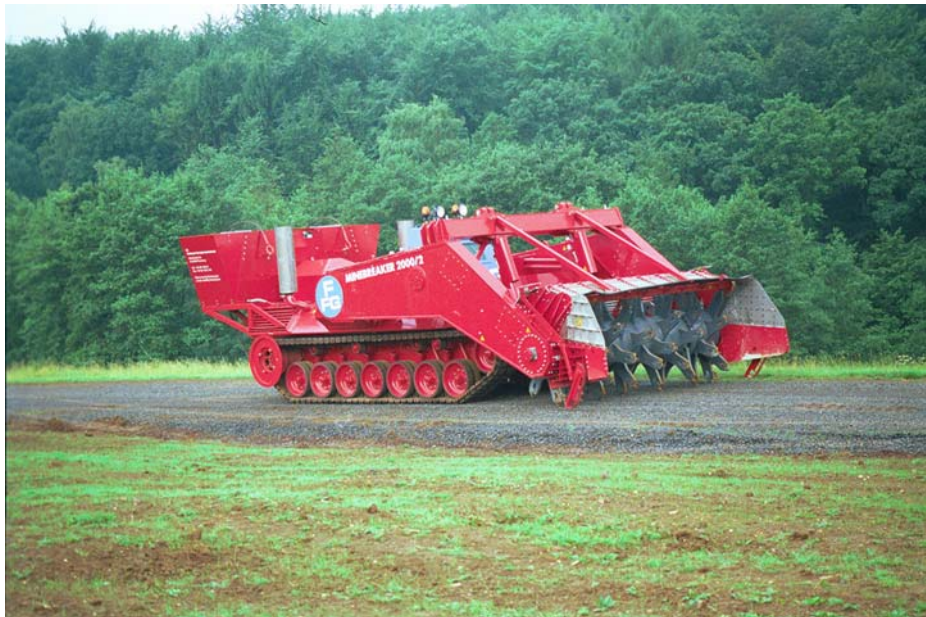
The mine clearance device MINEBREAKER consists of a Leopard 1 chassis, a hydraulically-powered rotating drum, mounted at the front of the vehicle, and an armored driver cabin. Due to its modular design, the tiller unit of Minebreaker can be fitted to other basic vehicles or carriers. The vehicle is powered by a 610 kW diesel engine of MTU Cie.

The tiller unit is composed of a tilling drum with steel teeth of Wolfram-Carbide.

The device has a clearance depth capacity of up to 50 cm, either detonating or destroying the mines mechanically.

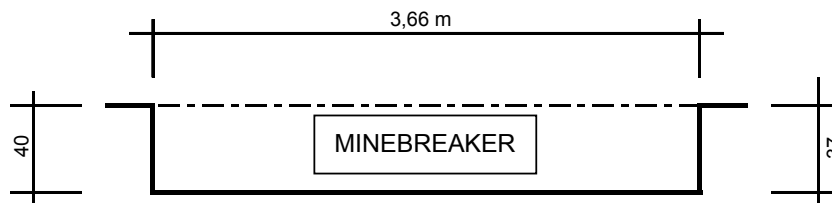
In the following sketch (not at scale) the tiller transversal section is represented:

The clearance width corresponds to the data given by the manufacturer.

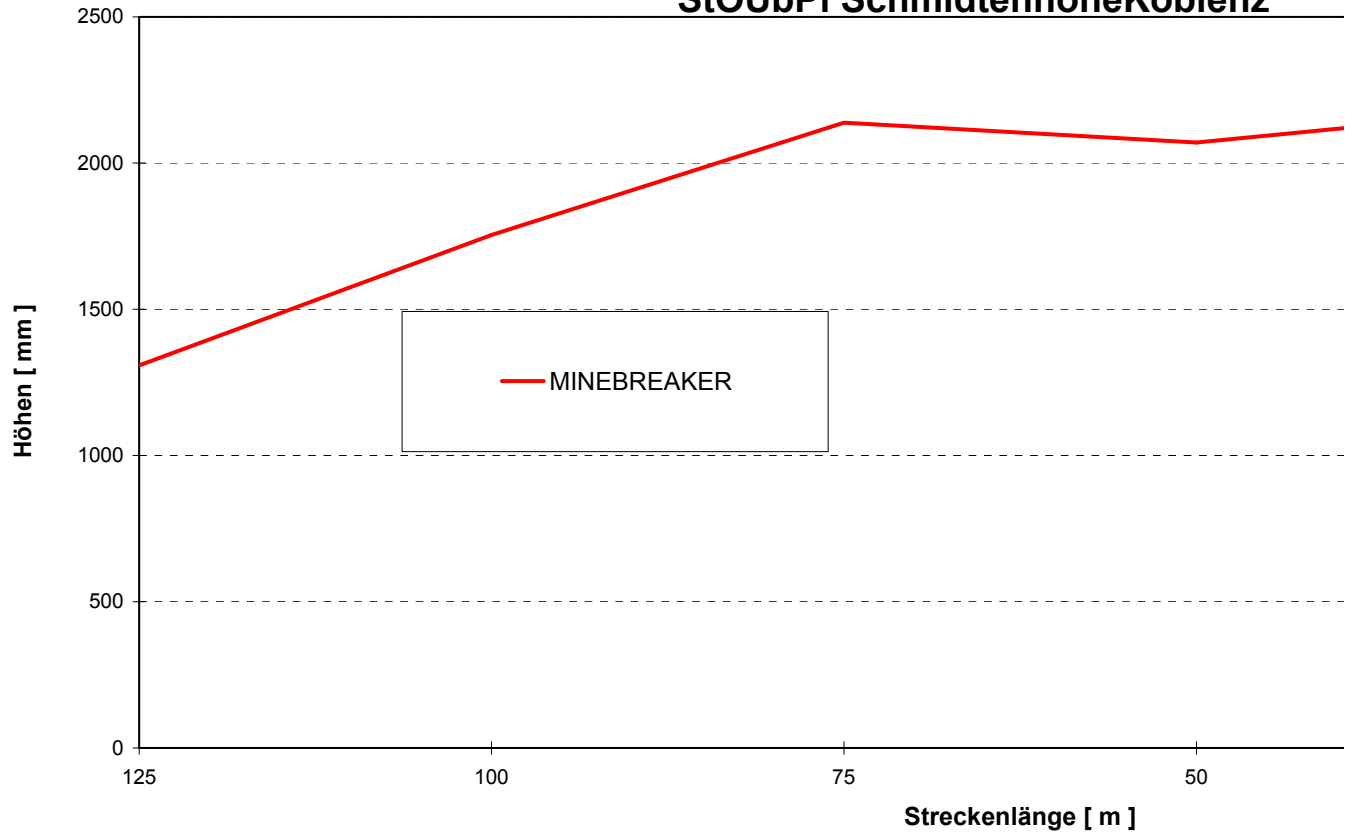
Geländeprofil der Vorversuchsstrecke StOÜbPI Schmidtenhöhe Koblenz

The grass area of the StOÜbPI Schmidtenhöhe shows limited changes in terrain topography along and across the test lanes. [Annex 3](#) (diagram) shows a representation of the test field topography along the test lane

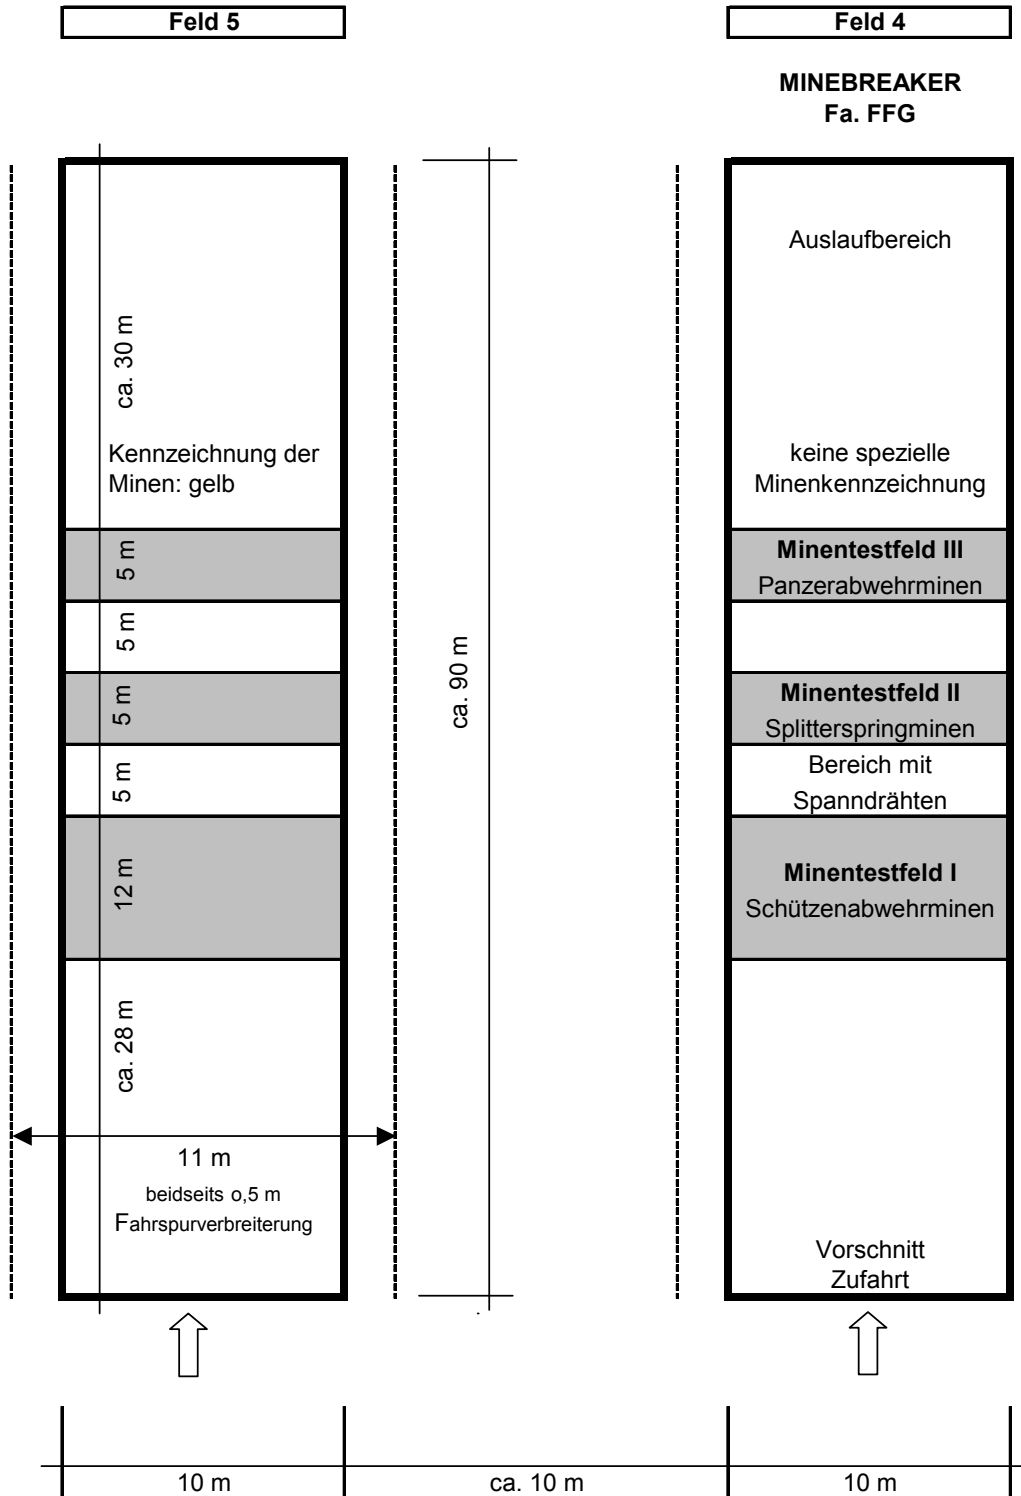
Teststrecke für Räumversuche WTD 91, Meppen

The prepared clearance lane at WTD 91 is provided in [Annex 4](#), whereas the one at StOÜbPI Schmidtenhöhe in [Annex 5](#).

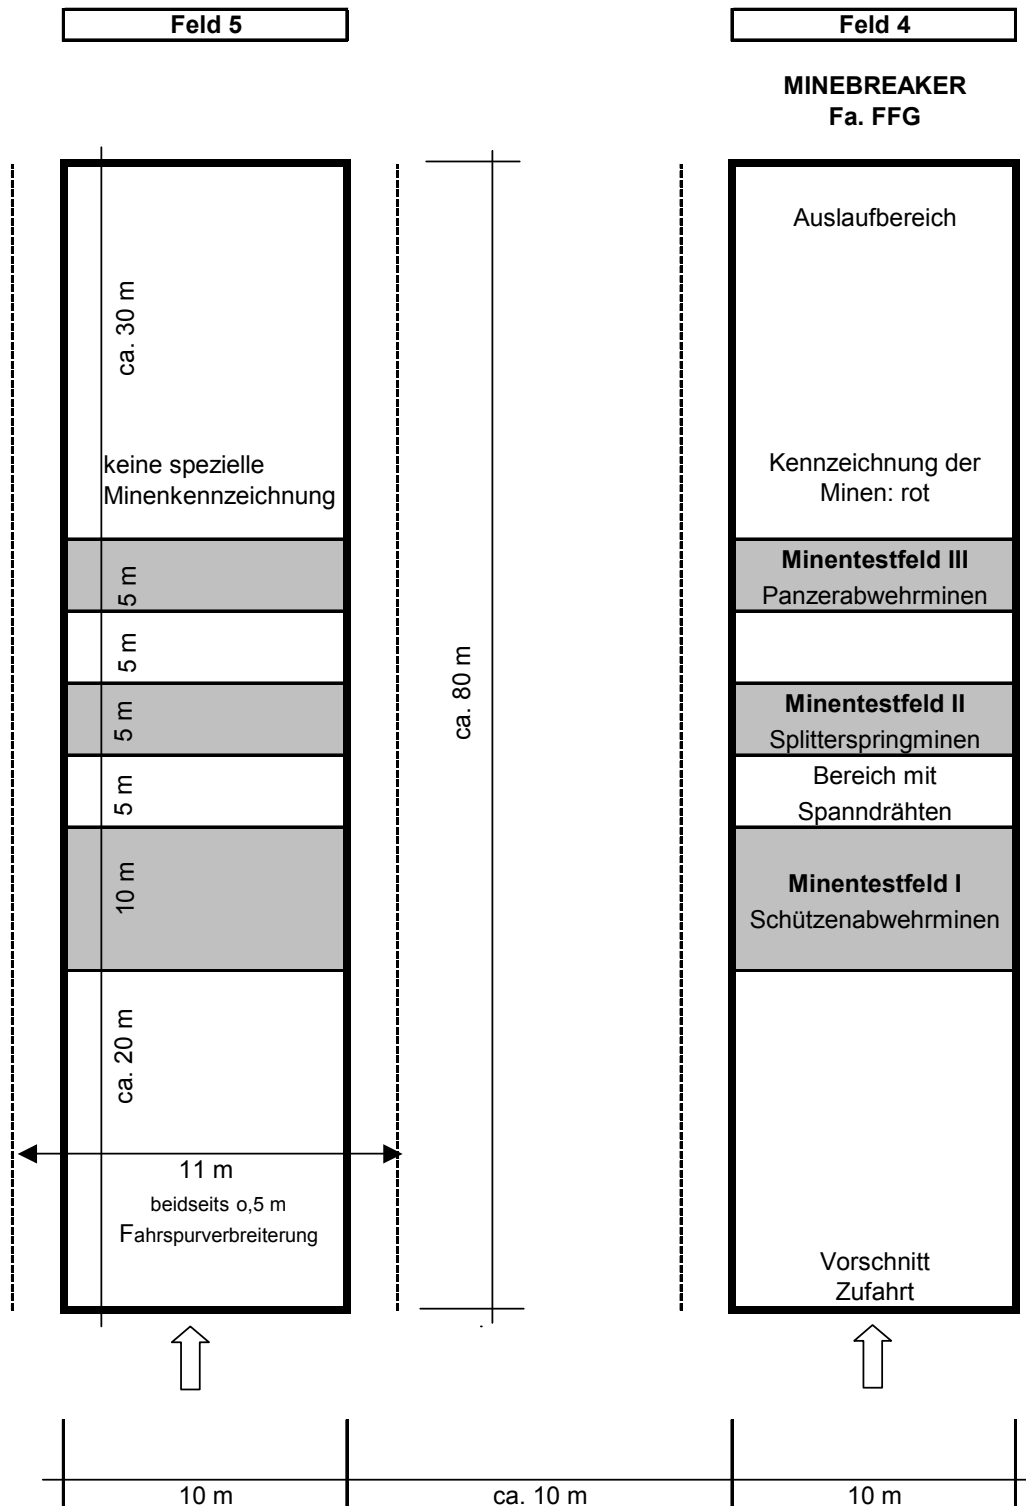
Teststrecke für Räumversuche StÜbPI Schmidtenhöhe, Koblenz

The differences in the length of the test lanes is due to the fact that, on the paths of the StOÜbPI Schmidtenhöhe the starting area had to be shortened.

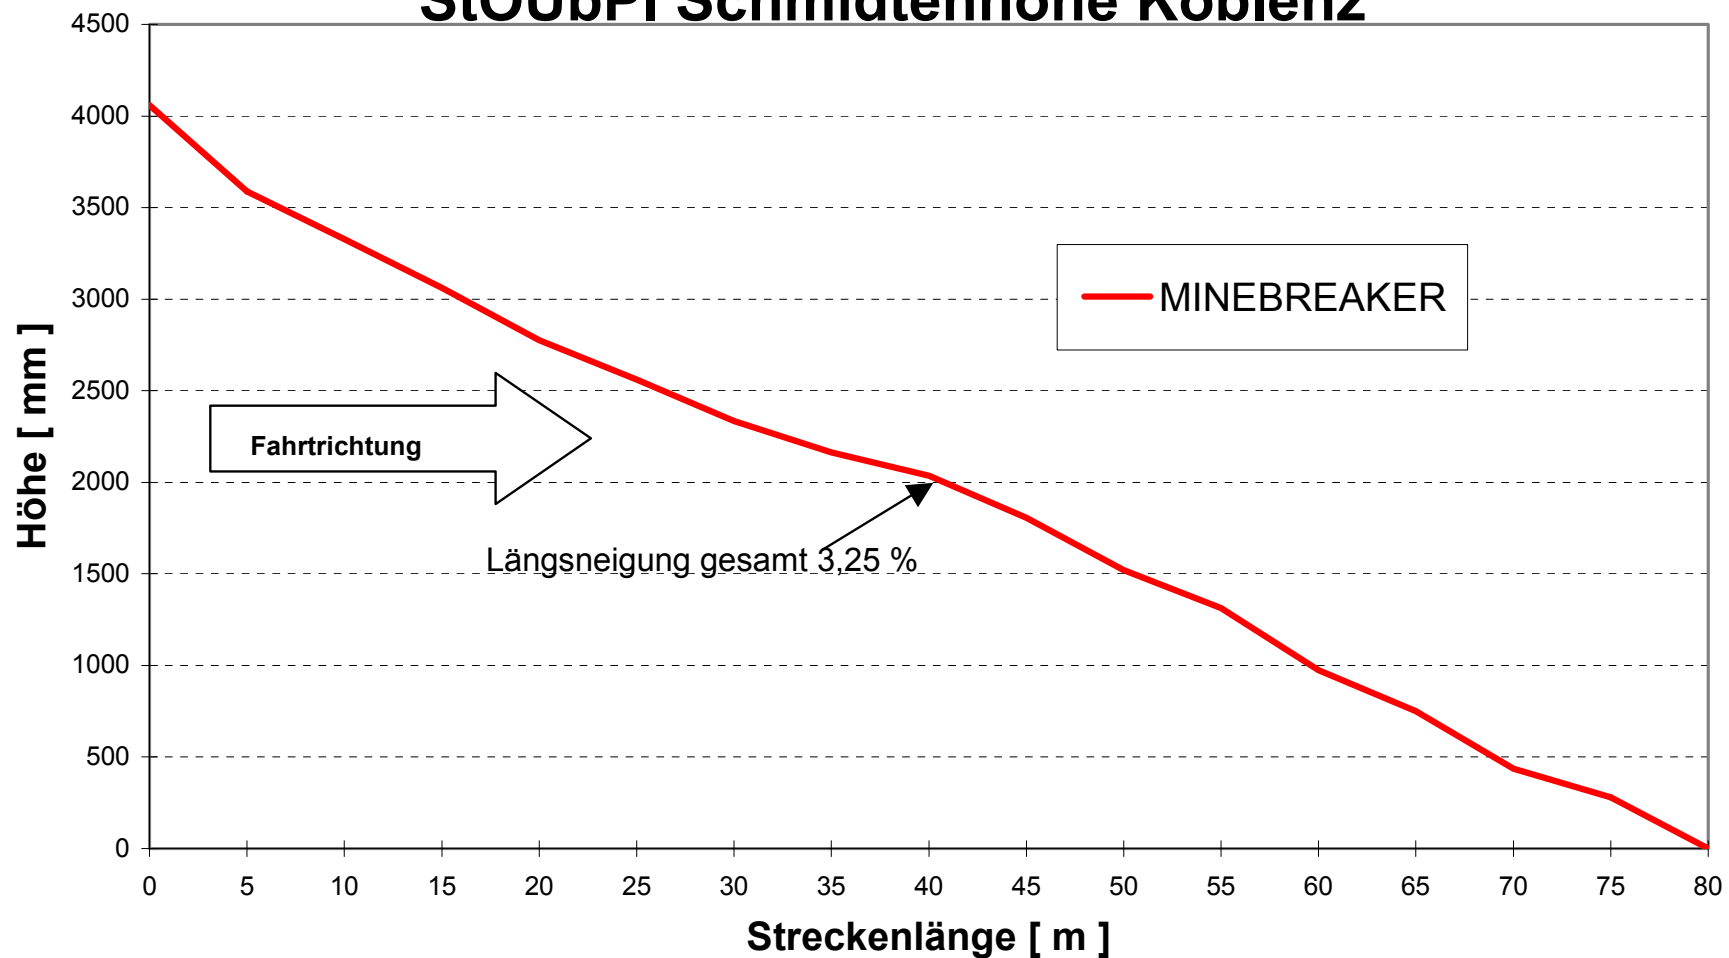
Geländeprofil der Räumversuchsstrecke StOÜbPI Schmidtenhöhe Koblenz

The topography along the test lane on the StOÜbPI Schmidtenhöhe is visible in [Annex 6](#) and the crosswise slope in the context of the mine test fields amounts to:

Field 4 MINEBREAKER 1,2° to 2,3°

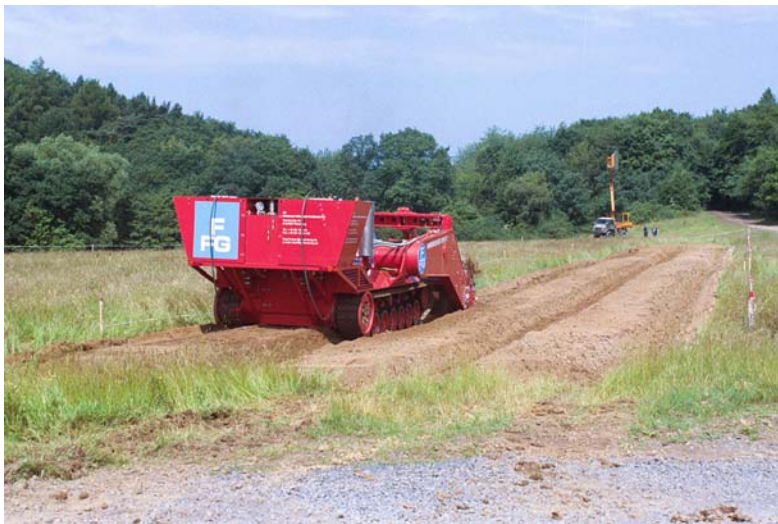
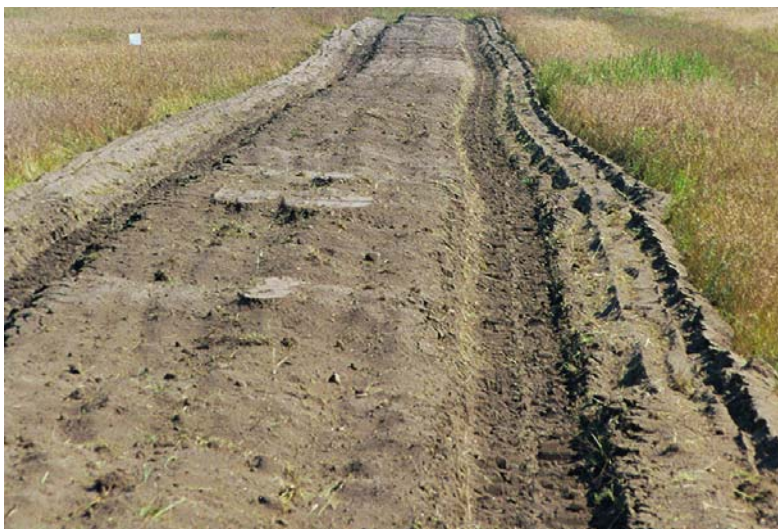
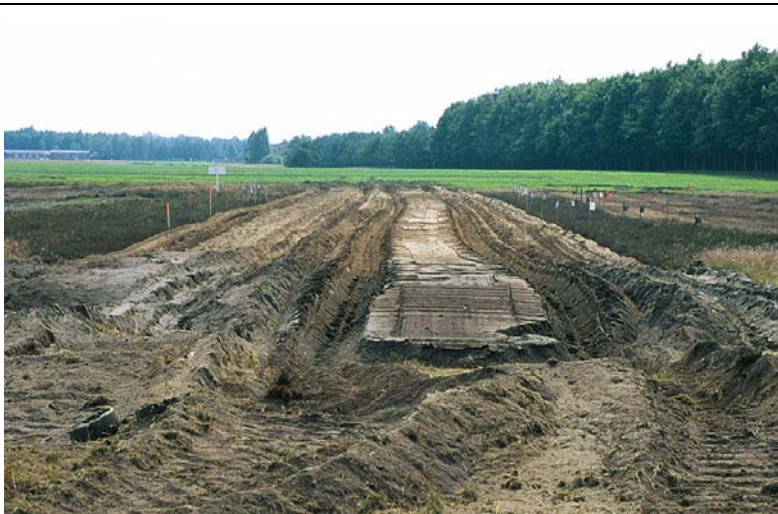
**Picture 7**

MineBreaker
test lanes / moving track

MineBreaker
Test lanes / moving track

Pictures showing the condition of the test lanes after the clearance trials are provided in [Annex 15 picture 7 to 9](#).

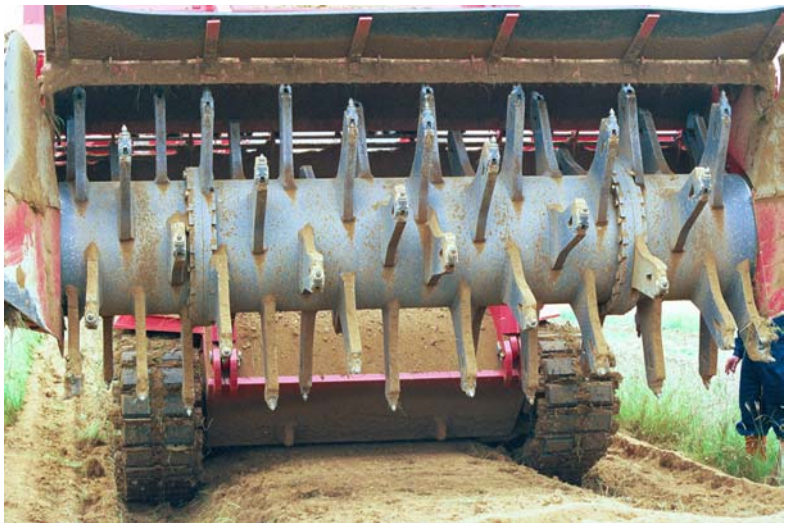
<p>Picture 10</p> <p>MineBreaker Tiller condition after the trials at the Schmidtenhöhe</p>

After the clearance trials no damages were visible to the tiller and no steel teeth were missing.

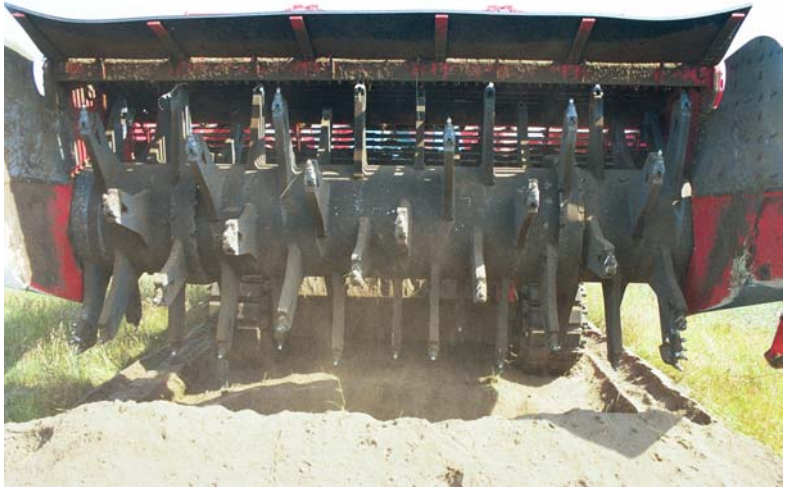
<p>Picture 11</p> <p>MineBreaker Tiller condition after the trials at the WTD 91</p>

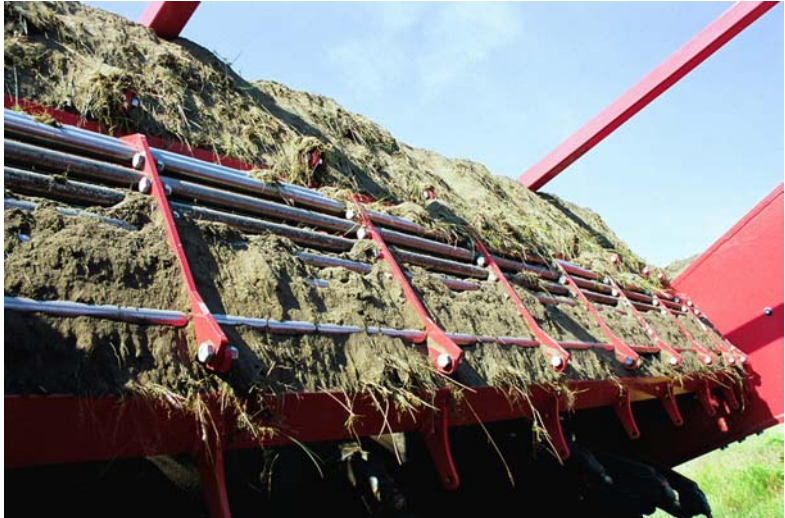
<p>Picture 12</p> <p>MineBreaker Tiller coverage after the trials at the WTD 91</p>

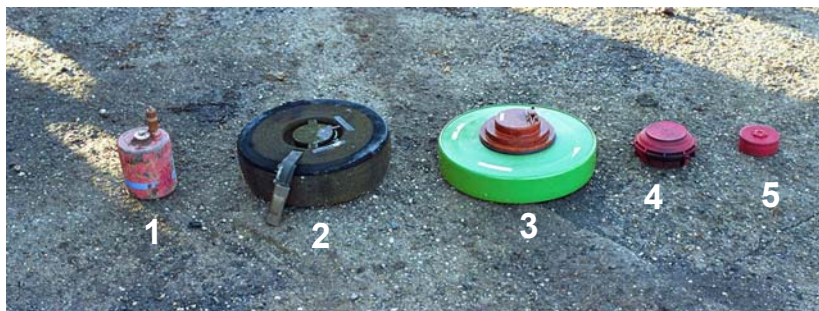
Picture 14
Used mines

- 1 DM 31 Splitterspringmine
- 2 DM 21 Panzerabwehrmine
- 3 TM 62P3 Panzerabwehrmine
- 4 PPM-2 Schützenabwehrmine
- 5 DM 18 Schützenabwehrmine

[See Annex 15 picture 14 and 15](#)

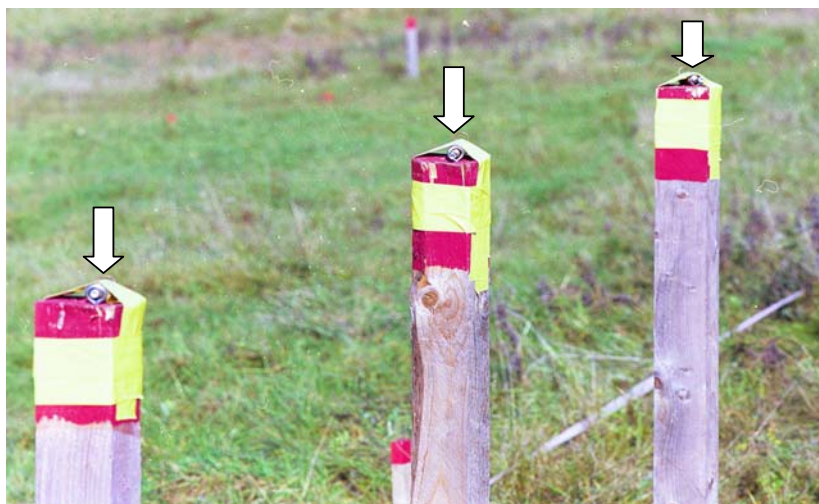
Picture 15
Mine fuse
MIZ DM 56 A1B1

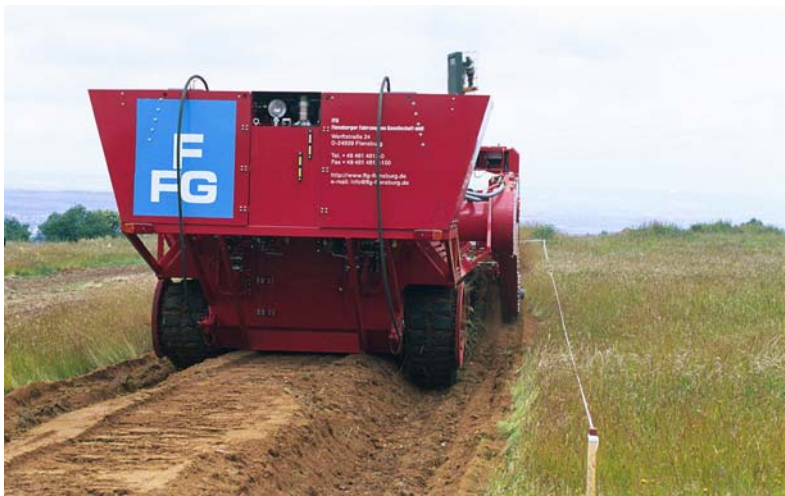
<p>Picture 18</p> <p>MineBreaker Because of the side plates no soil was pushed sideways of the clearance track</p>

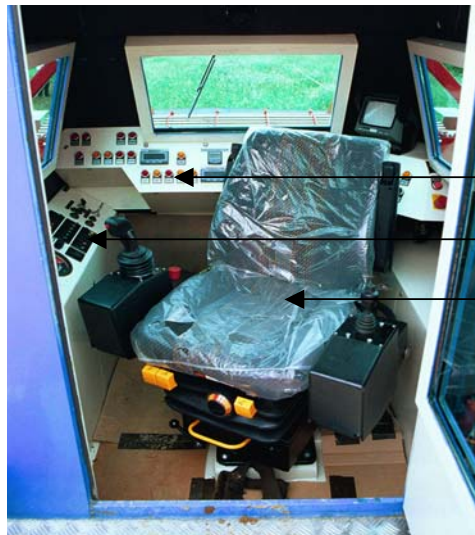
- ← Bedienpult Räumereinrichtung
- ← Bedienpult Fahreinrichtung
- ← schwenkbarer Sitz

Picture 19
MineBreaker protected driver cabin

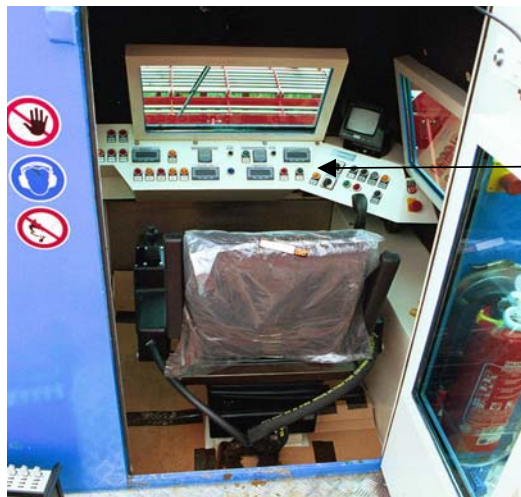
- ← Bedienpult Räumereinrichtung

Picture 20
MineBreaker protected driver cabin

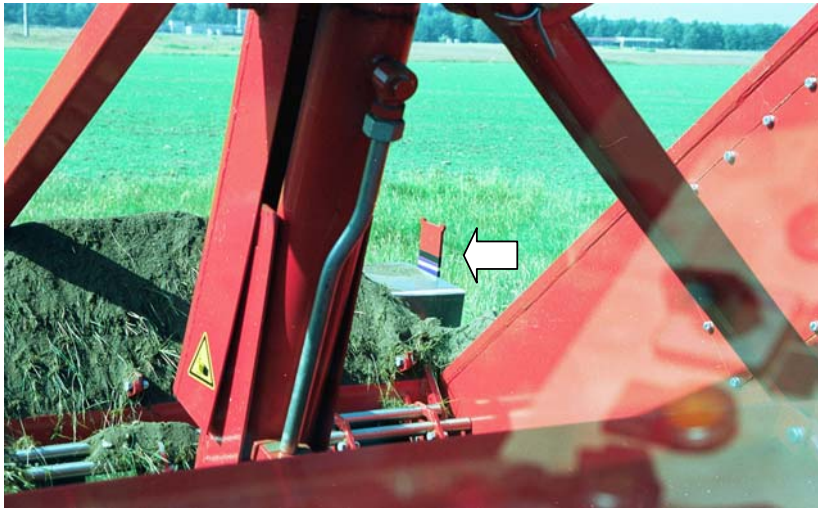
**Picture 22**

MineBreaker
View on the depth feeler system

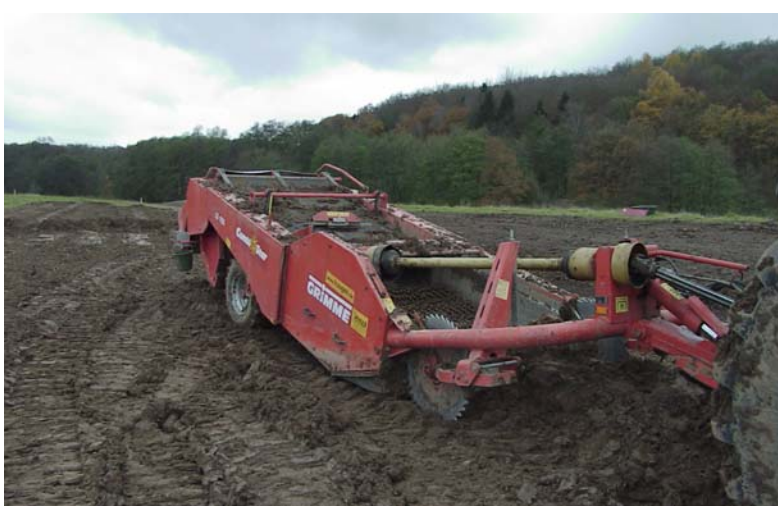
**Picture 27**

Search for mine
fragments using the rock
collector

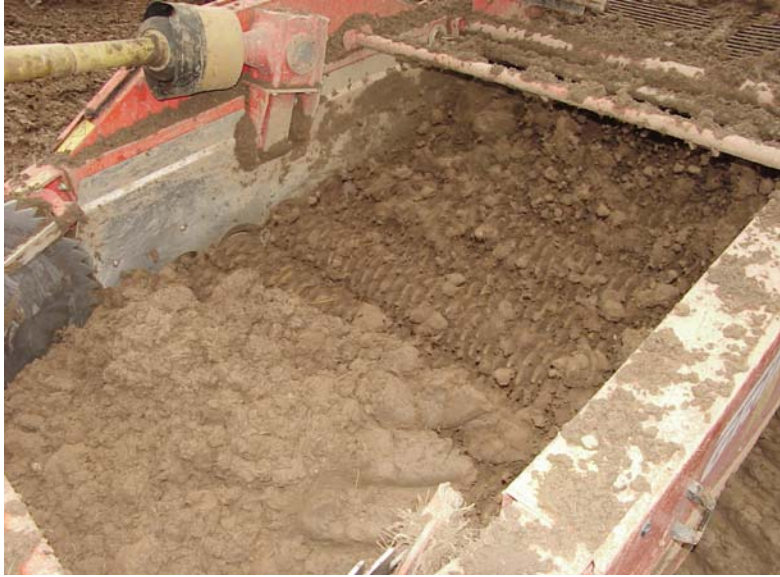
Picture 28 Search for mine fragments using the rock collector
