# LANDMINE CLEARANCE TEST FACILITY

# WTD 51

## Summary report

Planned object: Mechanical Mine Clearance device

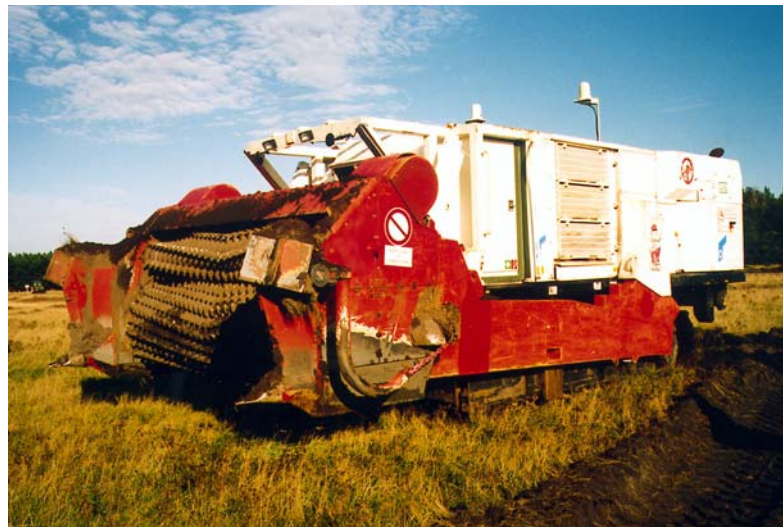
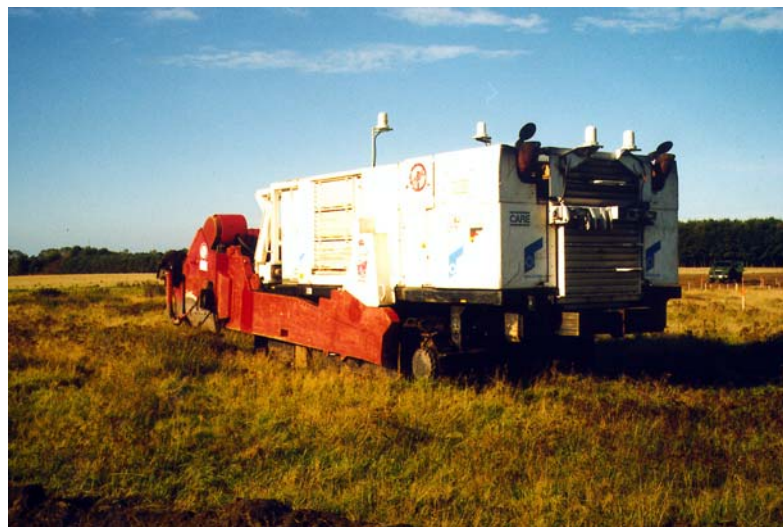
**Picture 1**

Overall view,  
front left

Overall view, rear left

The tiller unit consists of two hydraulically-driven tiller drums turning in opposite directions. The tiller drums are equipped with changeable Wolfram-Carbide chisels.

The excavated soil is carried through the drum between a loop of about 3 cm, so that all the mines get detonated or mechanically broken.

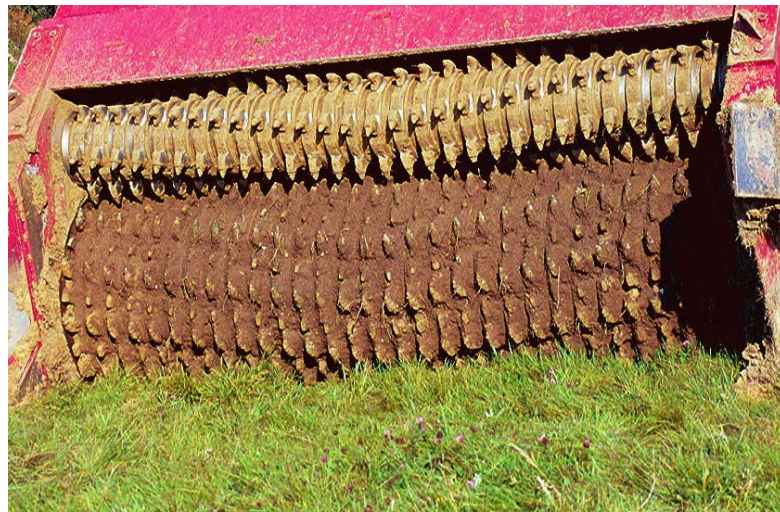
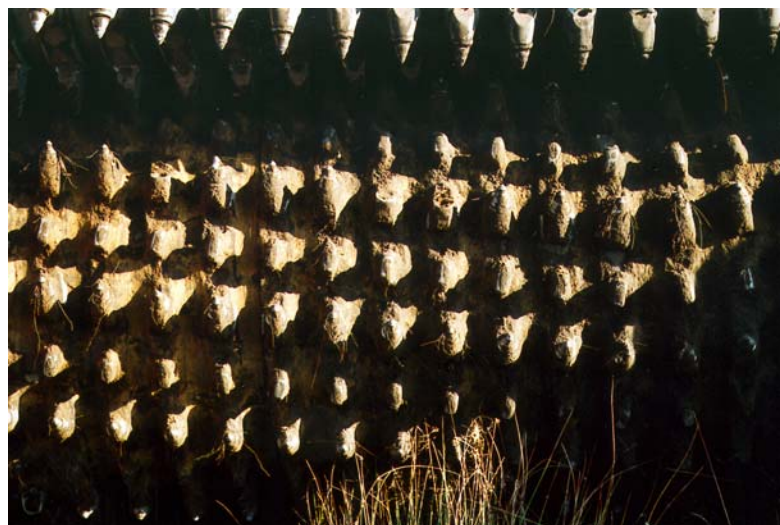
**Picture 10**

Condition of the tiller drums after the trials on WTD 91

The clayey soil of the Schmidtenhöhe stuck to the lower tiller drum so that the teeth heads were visible only for 2 to 3 cm. This limited the clearance efficiency. The upper tiller was because of the higher rotating velocity free of soil ([see Annex 15 picture 13 to 15](#)). The tiller condition after the trial on the WTD 91 in Meppen is shown in [Annex 15 pictures 10 to 12](#).

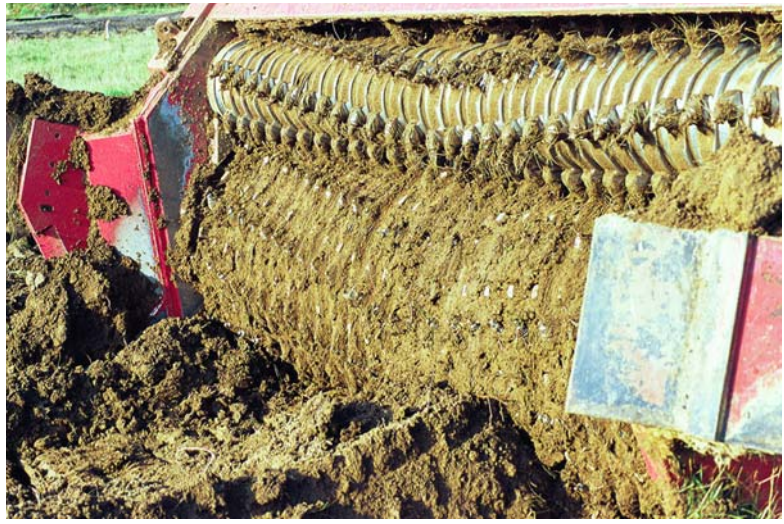
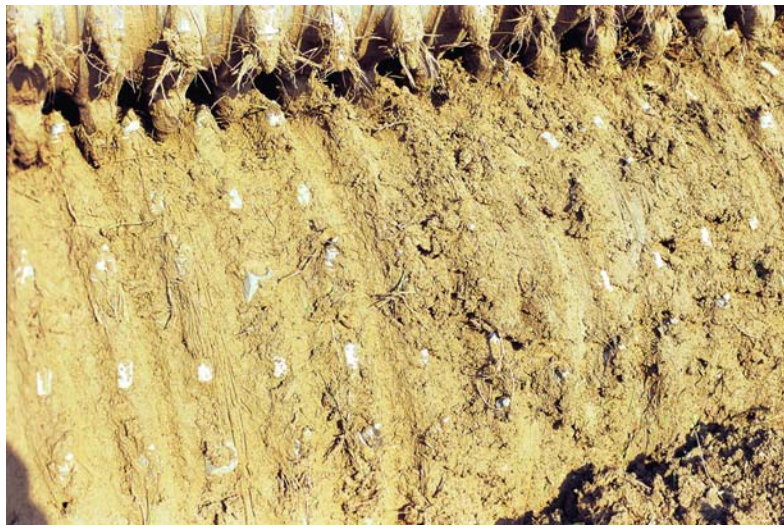
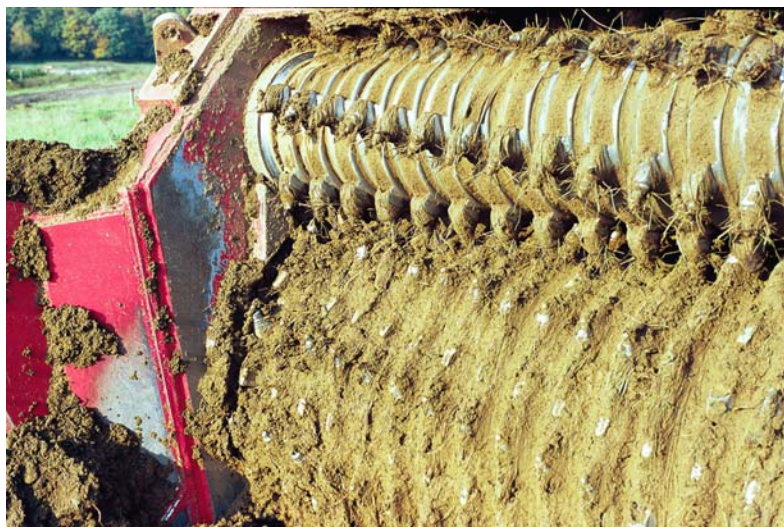
<p><b>Picture 13</b></p> <p>RHINO</p> <p>Condition of the tiller drums after the trials on Schmidtenhöhe</p>

<p><b>Picture 14</b></p> <p>RHINO</p> <p>Condition of the tiller drums after the trials on Schmidtenhöhe</p>

<p><b>Picture 15</b></p> <p>RHINO</p> <p>Condition of the tiller drums after the trials on Schmidtenhöhe</p>

In clayey soil the machine's lower tiller drum clogged so that the teeth heads were merely visible. As a consequence the soil was pushed forward in front of the vehicle and not treated. This caused an AP-fragmentation mine DM 31 to be missed.

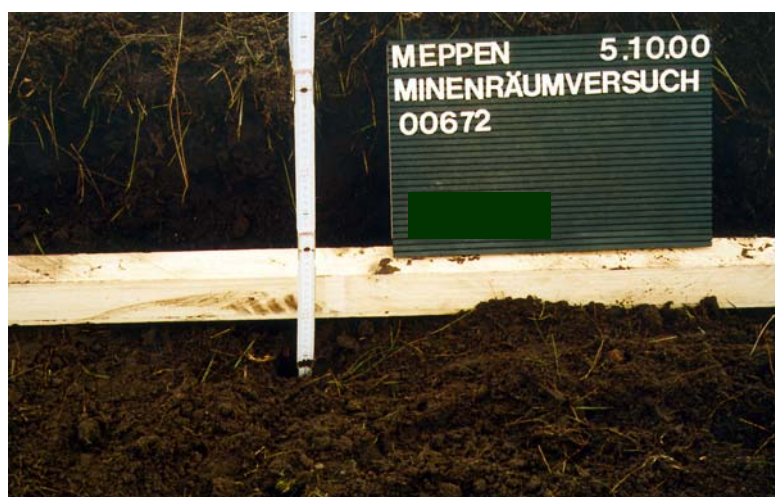
**Picture 18**

Measurement of  
Clearance depth

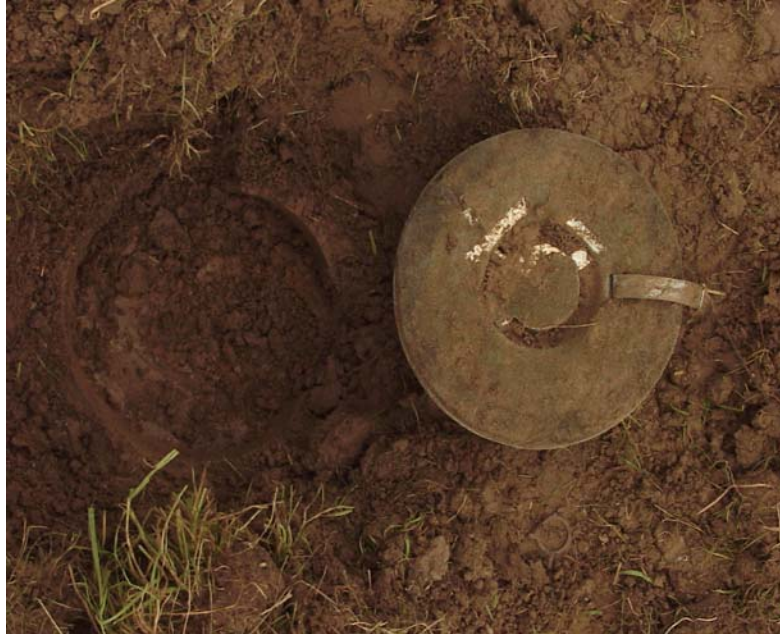
**Picture 19**

Schmidtenhöhe  
DM 21 run over by  
RHINO

In the context of the trial the critical mines found are represented in [Annex 15 picture 19 and 20](#).

The required clearance depth of 30 cm was not maintained, neither in sandy nor in clayey soil. In clayey soil, an AP-mine DM 21 buried at 15 cm depth, was only slightly damaged at its upper part and a Russian AP-mine TM 62P3 buried at 20 cm depth was left untouched.

1 ATM DM21 buried at a depth of 15 cm was missed by the machine and remained buried at its initial location. However, it had been hit by the drum and was found with a 10 mm wide and 30 mm long dent at the edge of the mine cover. It would probably have initiated, so that the clearance success could have been reached.

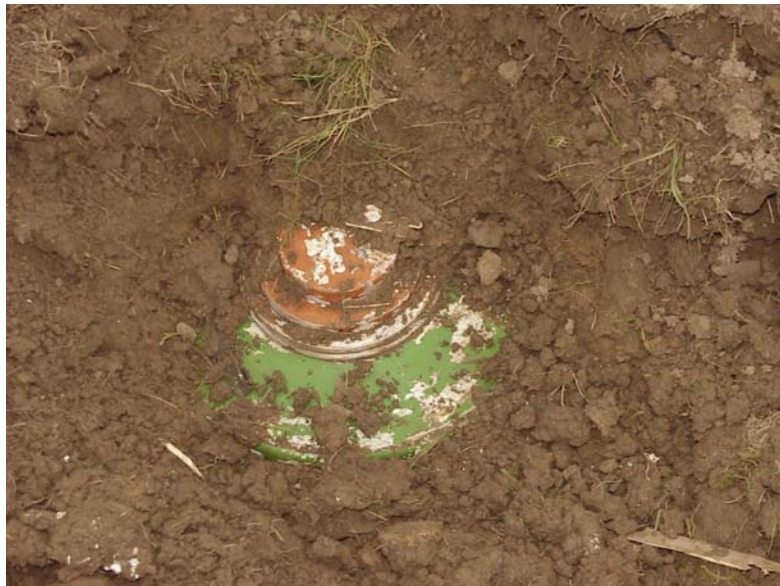
**Picture 20**

Schmidtenhöhe  
TM 62P3 run over  
by RHINO

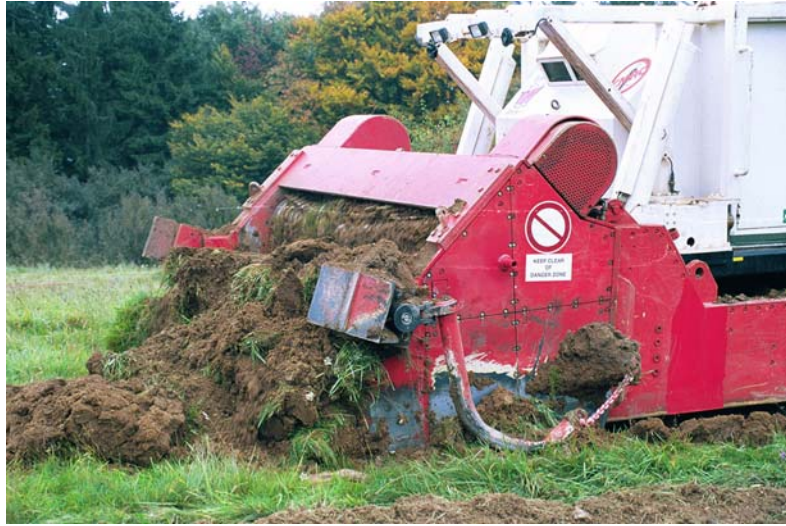
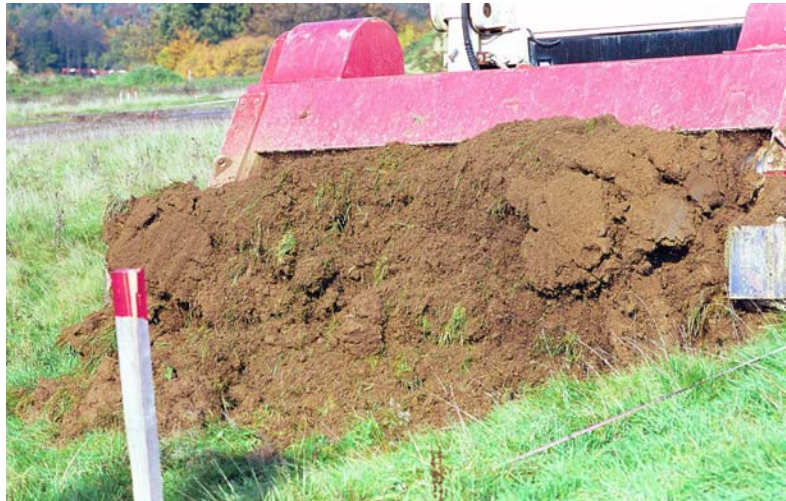
<p><b>Picture 22</b></p> <p>RHINO</p> <p>Larger soil bank in front of the tiller drum (Schmidtenhöhe)</p>

<p><b>Picture 23</b></p> <p>RHINO</p> <p>Larger soil bank in front of the tiller drum (Schmidtenhöhe)</p>

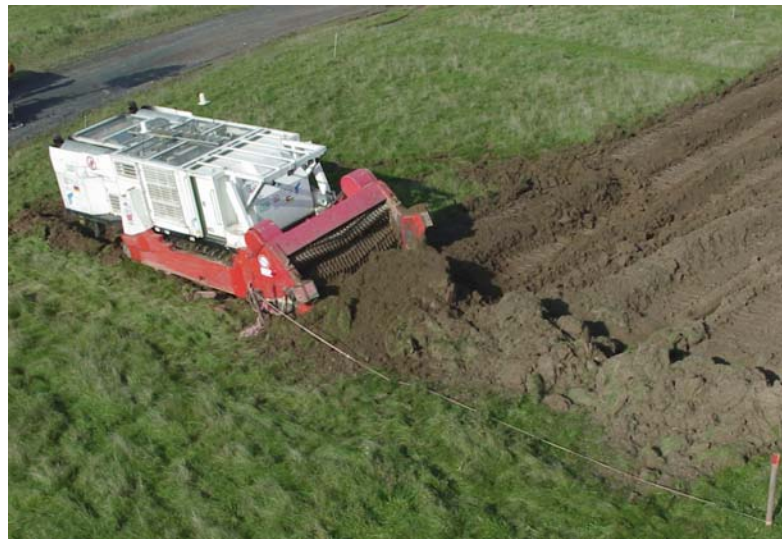
**Picture 24**

Tilling of the soil bank, perpendicular to the test lane

The sixth run served to till transversally the excavated amount of earth lifted from the mine field. No more initiations were observed.

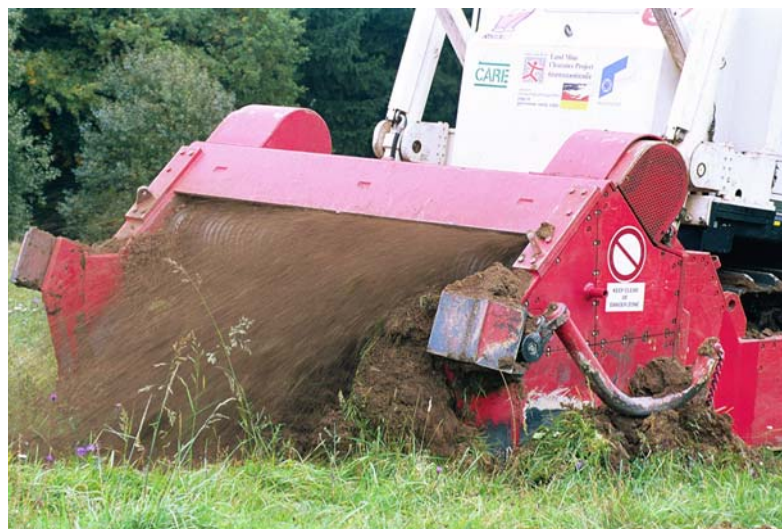
**Picture 25**

Passing over the soil with the depth feeler

During the clearance process, soil parts are pushed to the side of the tiller system. Since undetonated mines may be found in these parts of soil, it is needed to clear these parts twice by overlapping. Moreover, the soil parts left to the side cause errors in the measurements obtained with the depth feelers. The feelers, present at each side of the unit, capture through pre-programming always the most negative value. As a consequence of the excavated soil from the two tiller drums, left at the sides, and by simultaneously passing with the feelers, a higher clearance depth may be indicated than the one that was really obtained. As a result, deeper buried mines may be missed ([see Annex 15 picture 25](#)).

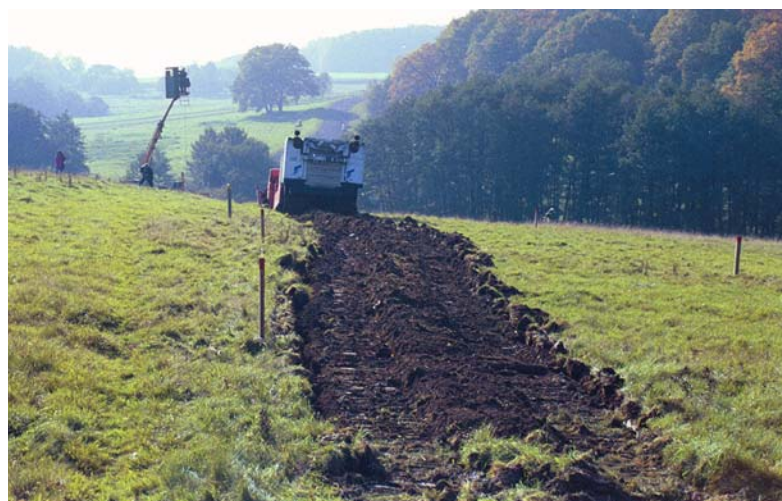
**Picture 26**

Driving off the lane during the clearance process on crosswise slope.

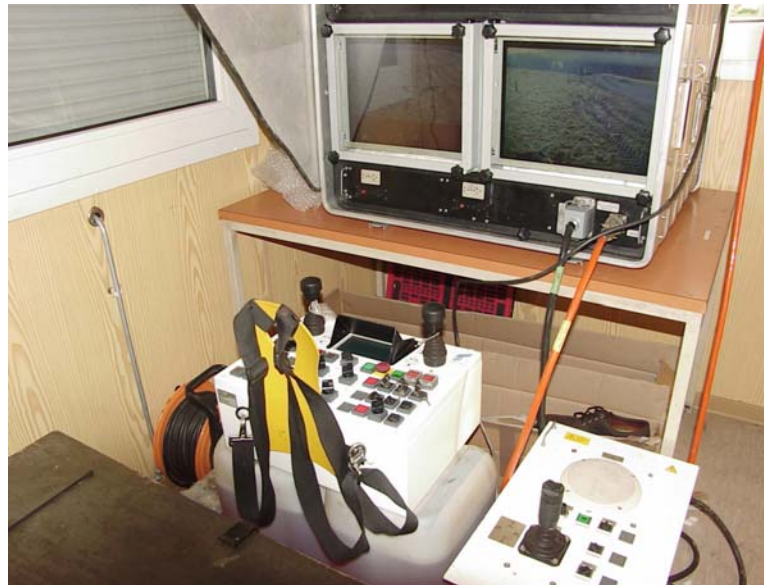
**Picture 28**

Remote Control operation system at the control station

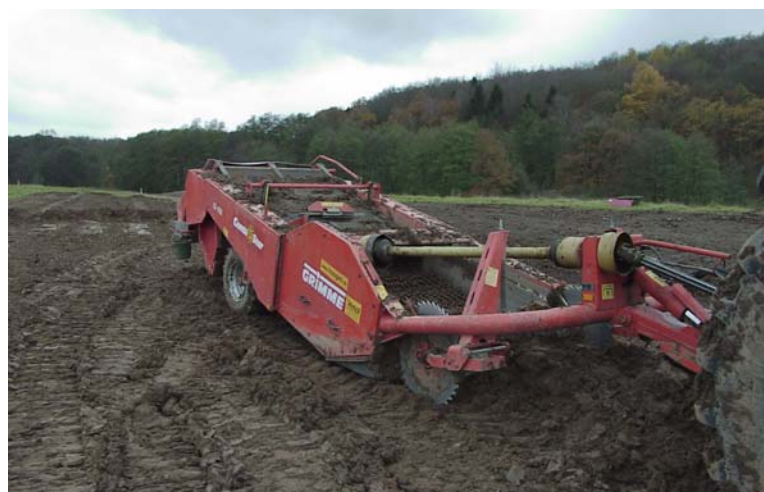
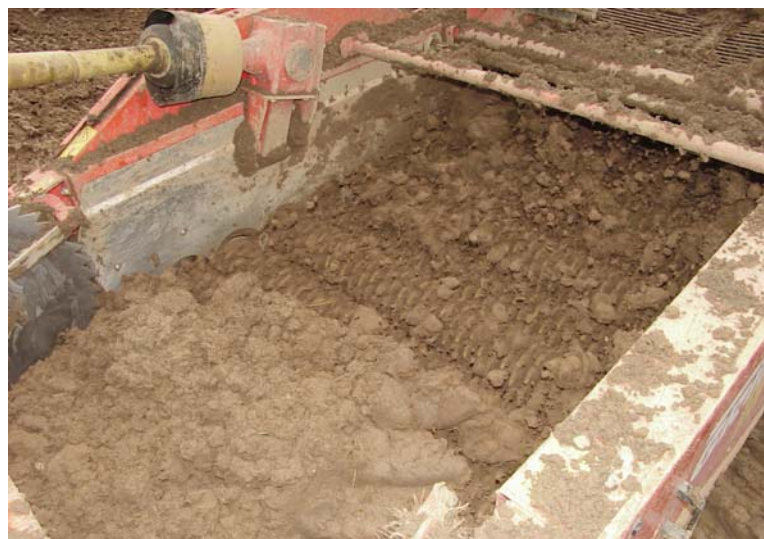
**Picture 31**

Searching of the ground for remaining mines with rock collector

In order to search for remaining mine fragments, a rock collector to sieve the ground was used.

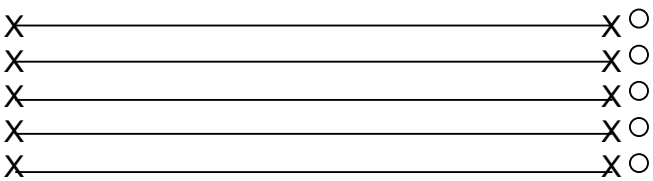
<p><u>MIZ DM 56 A1</u> With tripwire bound to wooden stick</p> <p>5 MIZ were initiated at the edge of the mine clearance device over the tightly bound trip, wire after the given time delay of 2 seconds.</p>
