Demining Programme Office in the Falkland Islands – Technical Support 2010

April 2010

TECHNICAL SUPPORT TO THE FALKLANDS DEMINING PROGRAMME

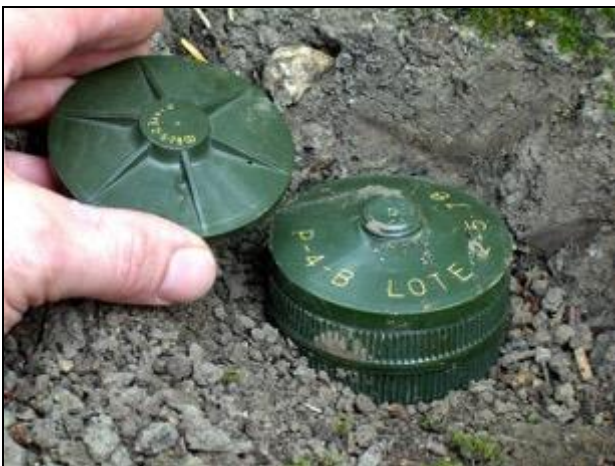
5. Documentary research showed that the Spanish P4B anti-personnel (AP) mine and C3B anti-tank (AT) mine had the lowest metal content of those likely to be encountered. The two mines share a similar initiation system, with a small steel spring being the sole metallic fuze component. The location of this spring, which sits lower within the AT mine, suggested that the C3B would be the harder target to detect.

Figure 1: The Spanish P4B anti-personnel mine, with safety cap to the left

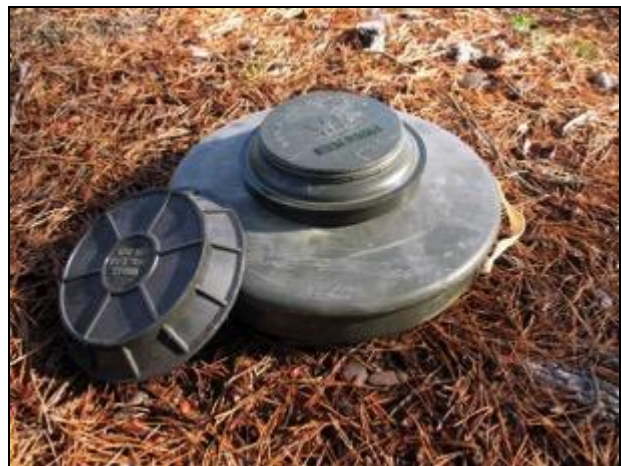
Figure 2: The Spanish C3B anti-tank mine, with safety cap to the left

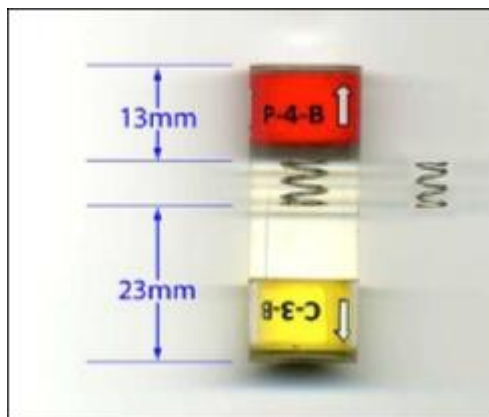
Figure 3

10. Precise measurements were taken to gauge the distance from the top surface of the mine to the spring, and a test piece designed. Since the same spring is used in both the P4B and C3B mines, and the spring is symmetrical around the horizontal axis, a single test piece could represent both mines. The off-set of the spring from each end of the test piece represented the location of the component within each mine. The resultant test piece is shown in **Figure 3**.

A detection test piece developed by CKA.

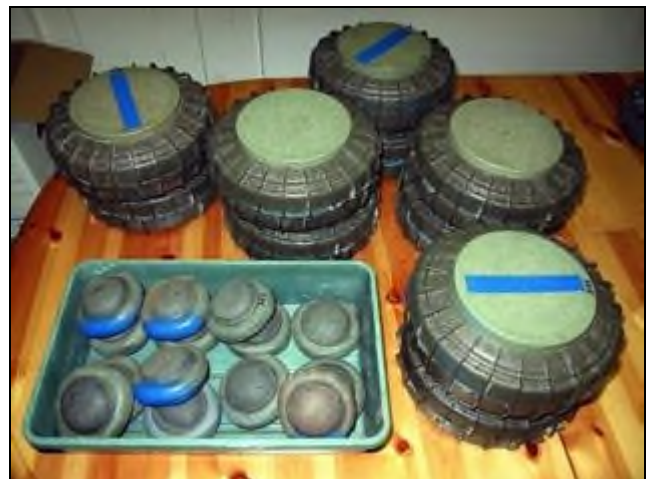
Figure 6: Inert SB-33 and SB-81 mines awaiting final safety checks and marking

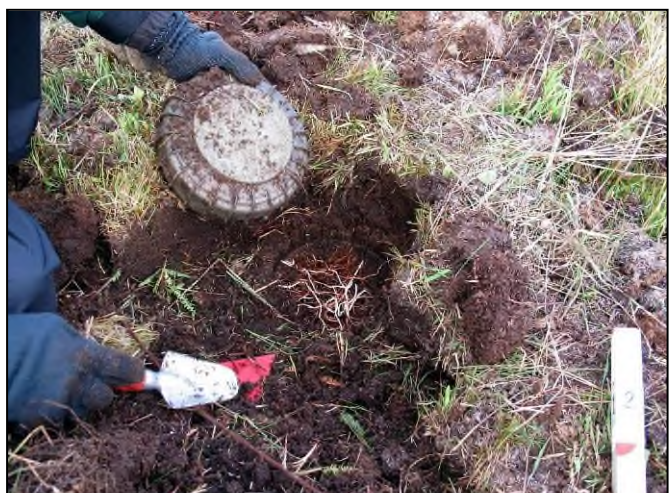
With the mine extracted, the underlying ground was photographed and examined

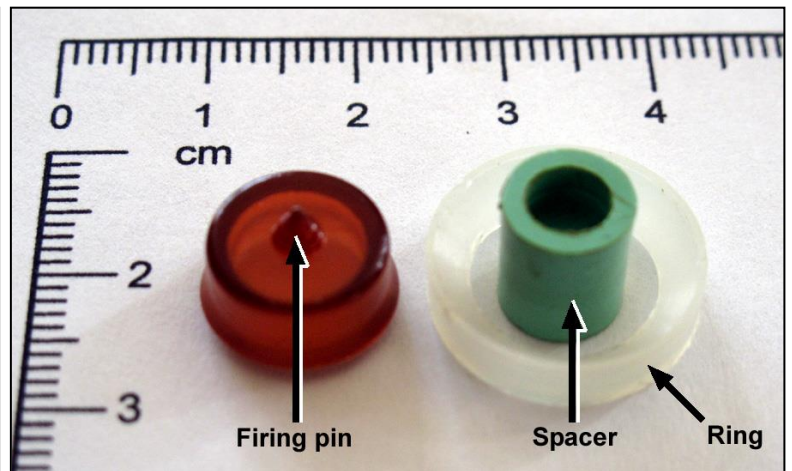
Figure 7

It is important to note that the P4B can function regardless of the spring's condition. The firing pin is made from polymethylacrylate plastic, which is unlikely to deteriorate significantly within the foreseeable future. It is forced through a polythene ring by a spacer and this action alone may be sufficient to cause initiation without the additional impetus of the spring. These plastic components are shown in Figure 7.

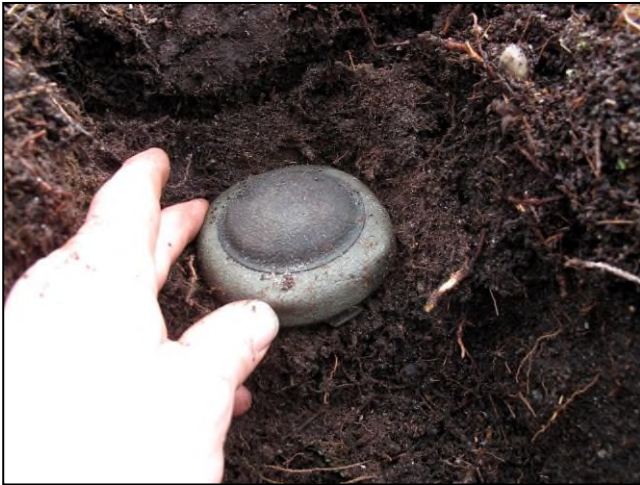
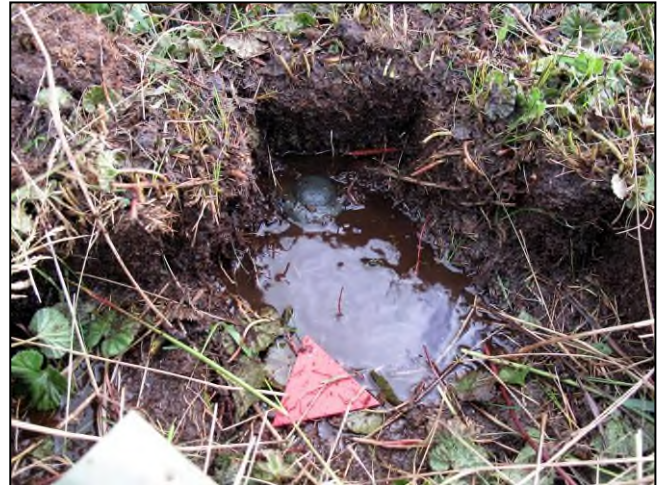
Seventeen SB-33 mines were recovered from a mixture of dry and wet sites (Figures 1 and 2). None of the SB-33 mines examined showed signs of significant external degradation, other than a notable increase in the profile of the rubber pressure plate; this is clear from Figures 3 and 4.

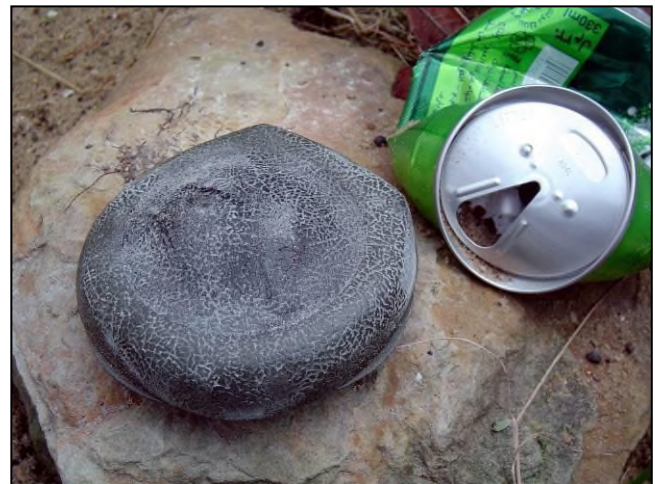
Figure 4: The normal appearance of the SB-33, with a relatively flat pressure plate

Expansion of the rubber appears to be due to the material softening when wet, although it continued to be waterproof. As the rubber dried, the height of the dome reduced noticeably, but not to the original profile.

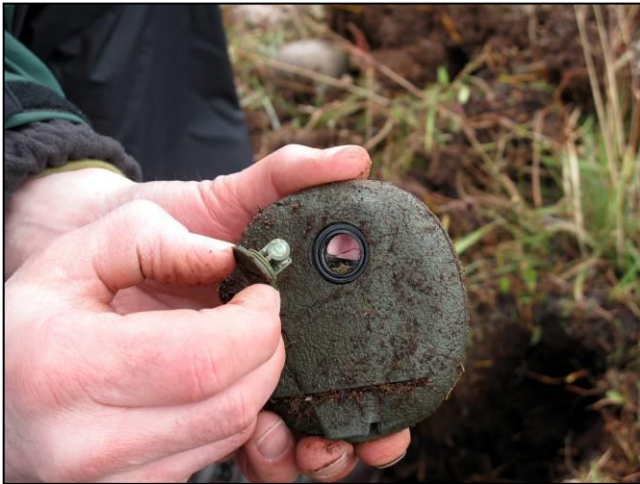
Figure 5

Mines were disarmed by unscrewing the detonator assembly from the base well (Figure 5); in most cases, this plug had been fitted tightly. Once disarmed, the two halves of the mine were unscrewed using a chain wrench (Figure 6) to access the internal components and main charge.

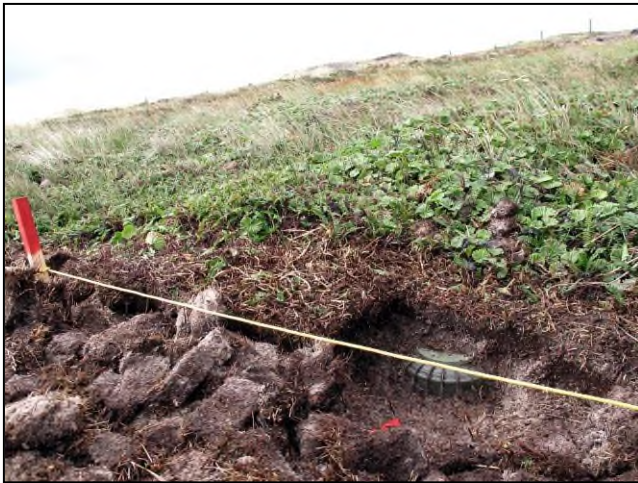
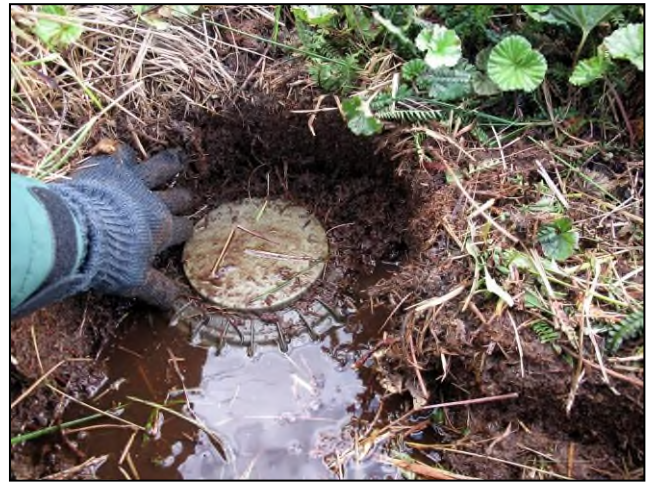
Fifteen SB-81 Anti-Tank (AT) mines were recovered from a mixture of dry and wet sites (Figures 1 and 2). None of these mines showed signs of significant external degradation; in fact, their appearance was virtually 'as new', as shown in Figures 3 and 4.

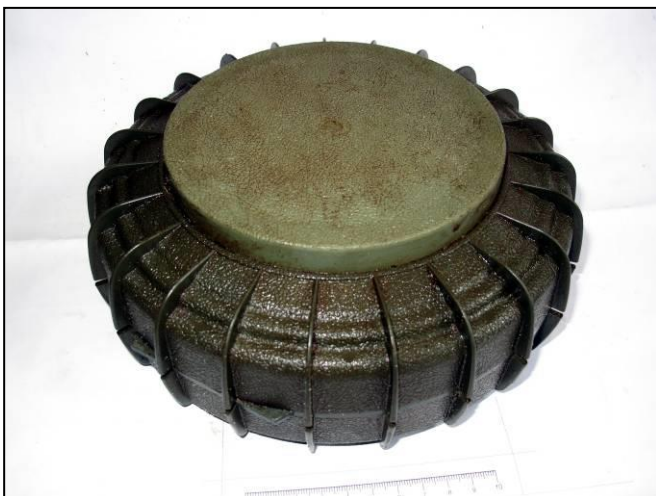
Figure 3: An SB-81 recovered from the Falklands

All of the mines examined had been buried in the ground and were not, therefore, exposed to sunlight. Polycarbonate is known to become brittle after prolonged exposure to sunlight, so it is probable that exposed mines would show more evidence of degradation.

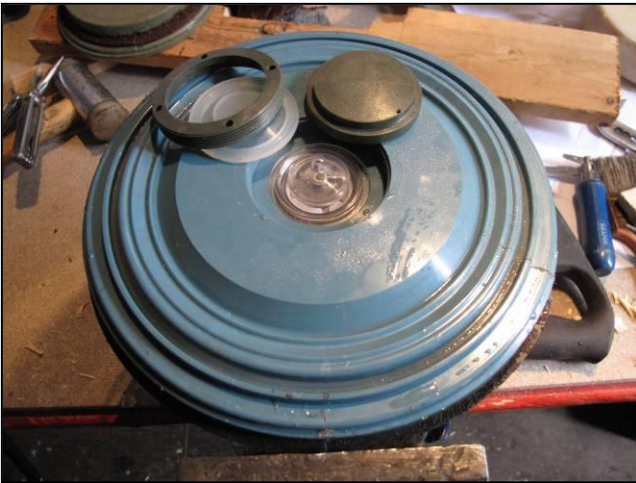
With the halves of the casing separated, the internal components could be examined. Figure 5 shows upper section of the mine with the pressure plate removed to reveal the top of the fuze assembly. The seal around the edge of the pressure plate is critical to the pneumatic function of the fuze; this is a common point of failure among Italian AT mines. Although small roots were present on the outside (Figure 6) all seals were intact.

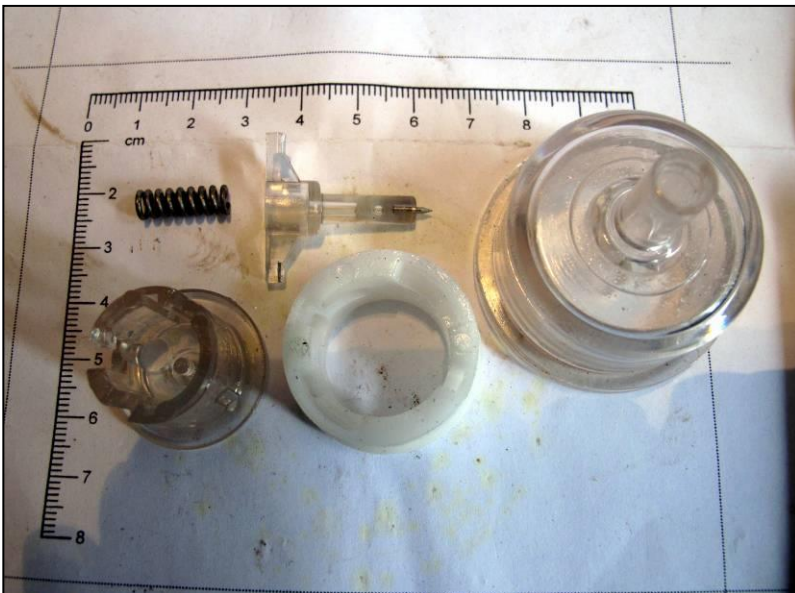
Figure 7 shows the major components of the fuze mechanism. The fuze is similar to that used in the SB-33, with most of the clear plastic internal fuze components made from polycarbonate.

As with the SB-33 mines, the SB-81s were generally well sealed, but several were damp inside. In many cases this had caused very minor rusting of the striker spring (which is made from spring steel 'piano wire'). This superficial corrosion would have no effect on the performance of the mechanism, nor would it effect the detectability of the mine. The firing pin is made from stainless steel and none of those examined showed any corrosion.
