Demining Programme Office in the Falkland Islands – Exploitation 2015

Submitted by: Fenix Insight Ltd

March 2015

FALKLAND ISLANDS LANDMINE EXPLOITATION – MARCH 2015

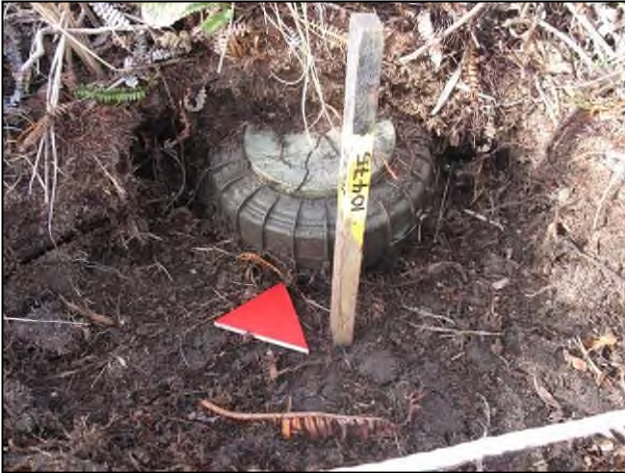
SB-81 mines were located and partially exposed by deminers, then recovered by CK

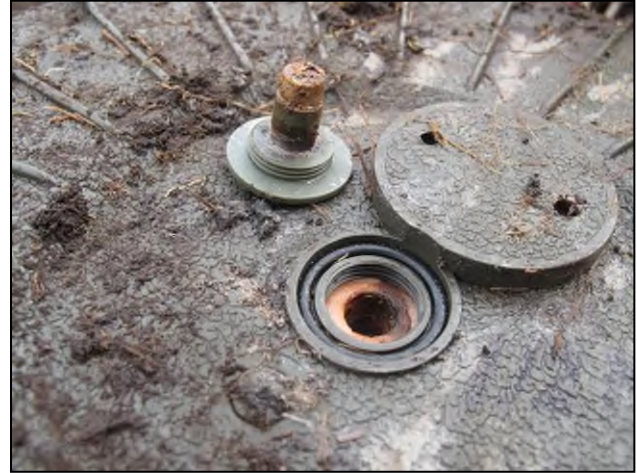
AT mines were examined and then defuzed in the minefield. The condition of detonators was noted

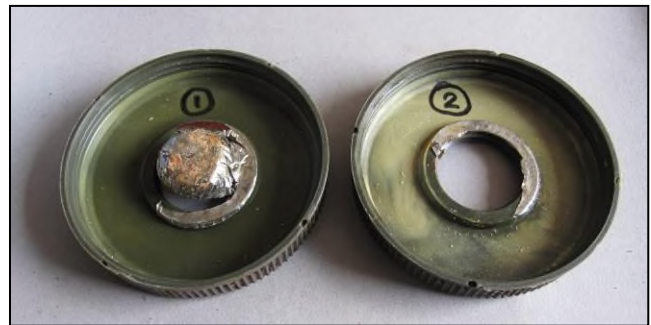
The foil is installed in the P4B body as a flat disc, but is broken when the fuze is fitted. In most cases, the foil ruptures in several places, creating 'fingers' that protrude into the fuze well. In some examples the foil remains virtually intact, while in others a portion is absent, but every P4B mine examined (including previous phases) has had some foil present.

View of the foils from the inside of the casing

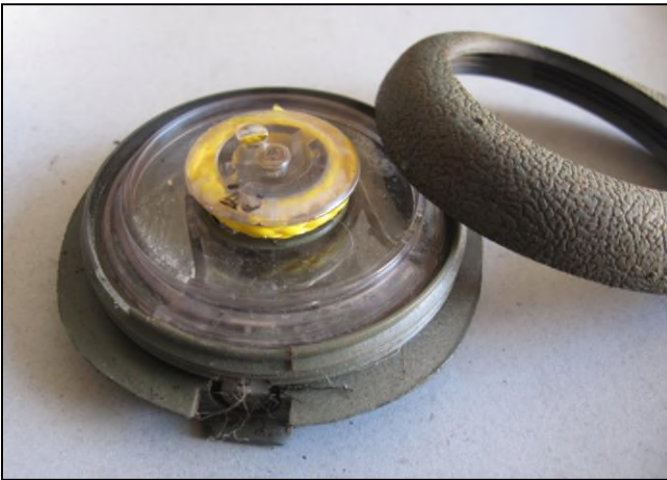
It is often possible to establish whether or not an SB-33 has been actuated by carefully feeling the position of the central plunger (through the rubber cover)

This inert model was produced - along with an actuated version - to illustrate the difference. The plunger is supported by a flexible ring so that it moves realistically, but cannot be actuated
